MAS004399 RU 24-33

# Rapid Update 757

## GranTurismo and GranCabrio – “Door to body” Connector gasket out of position

DATE: October 8, 2024

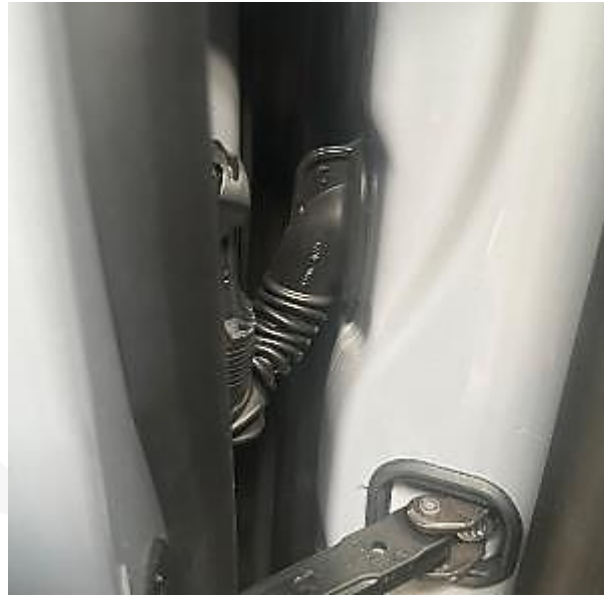
1. Always check ModisCS+ to see if the vehicle is involved in this action and if it has not been previously performed.
2. Locate the connector to be checked, in the internal area of the side door, both **right and left**.

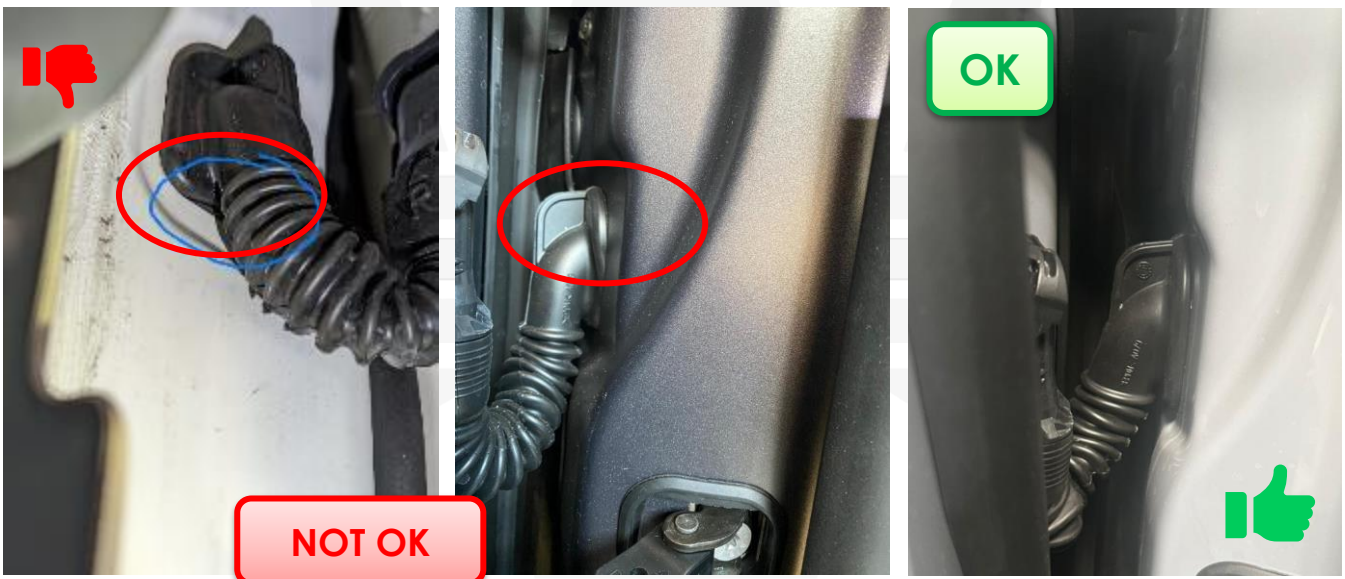
3. Check the correct positioning of the seal by hand, make sure the entire surface of the gasket is inserted, and that there are no lifting or deviations.

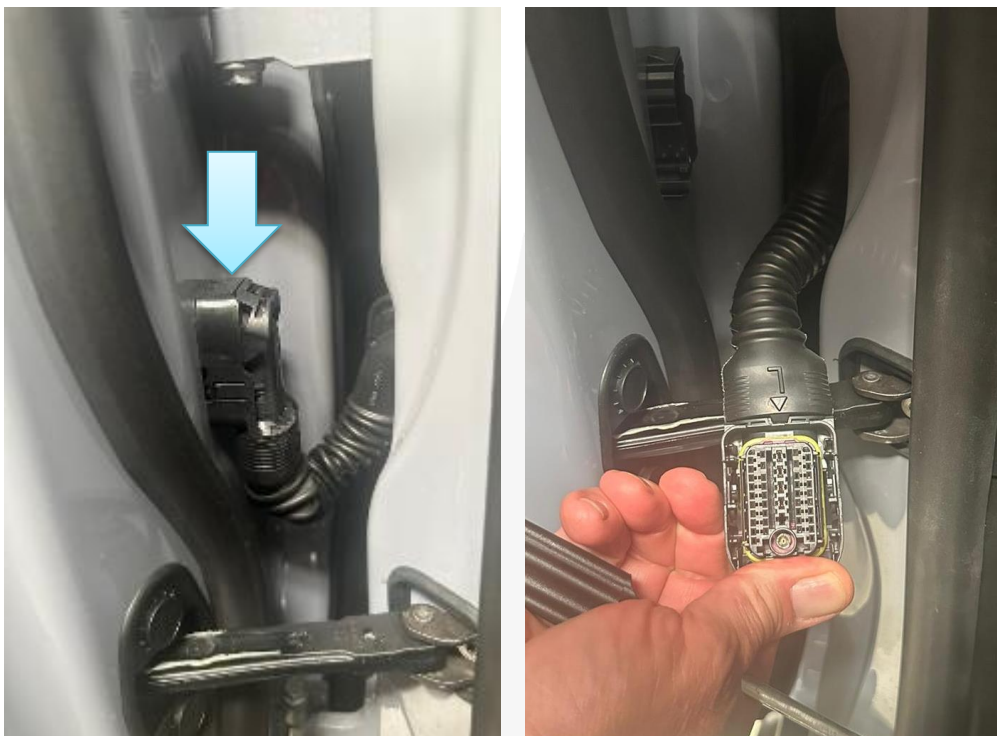
4. Check both doors. If the seal is **perfectly seated** to the body, the **vehicle is compliant**, and no further action is required. The vehicle can be released.
5. If the seal is not correctly seated to the body the vehicle is **non-compliant**. Proceed to the next steps.
6. If the seal was not seated correctly, there may be possible moisture inside the vehicle frame. In this regard, we ask you to carry out another additional test to completely exclude the presence of water.
7. Disconnect the electrical connector from its seat by unlocking the slide with a suitable tool and check for the presence of water and/or corrosion on the electrical PINS.  
If **OK** → No action required – re-connect the connector and continue to the next steps.  
If **NOT OK** → Open a BOL as support request and attach clear photos and videos.

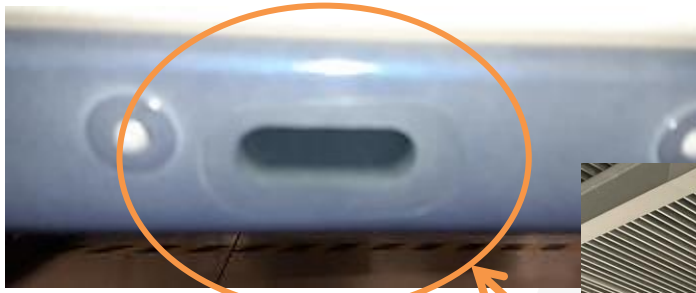
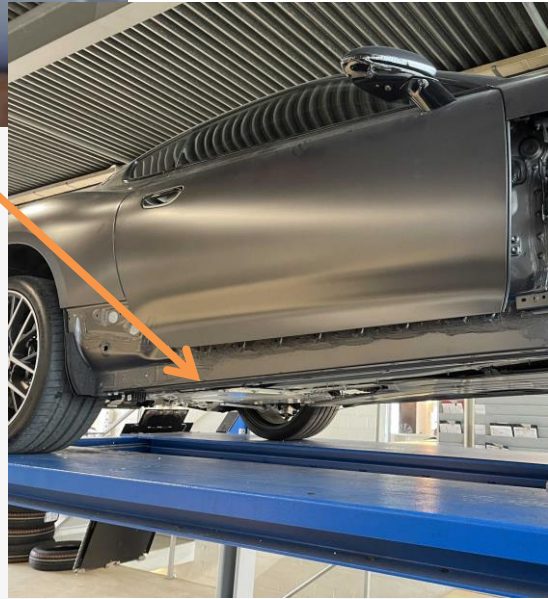
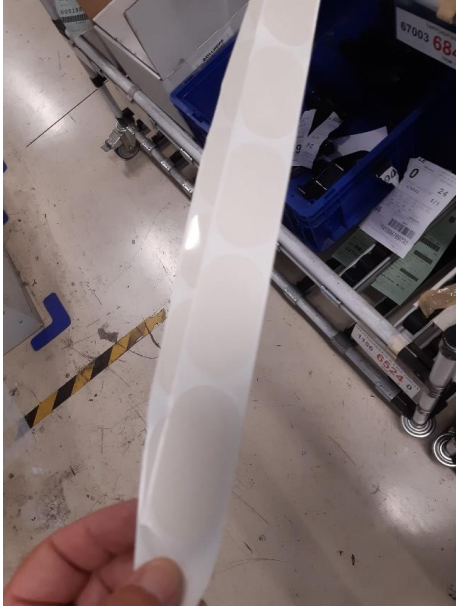
If, however, you should perceive the presence of liquid inside the vehicle, proceed with **draining the water** that may have collected inside the frame rails of the side members of the vehicle.

9. To drain the water, you can peel off the caps (clear stickers) on the side members of the vehicle, in the underbody area.
10. Remove the side shields following the instructions in the workshop manual:
  - a. **9.15.145 RH SIDE SKIRT Removal/Refitting - Replacement**
  - b. **9.15.146 LEFT SIDE SKIRT Removal/Refitting - Replacement**
11. Locate the body caps to be removed (6 on each side) on both sides of the vehicle and remove them.
12. Drain any water completely and **before replacing the cap (Clear stickers)**, use a compressed air to **make sure the frame has been completely dried.**

13. Restore the disassembled components by proceeding in reverse order to the disassembly procedure.
14. Procedure complete.
