MAS004402 RU 24-34

Rapid Update 758 GranTurismo GranCabrio – Doors vs Fender - Flush & Gap Check

DATE: October 8, 2024

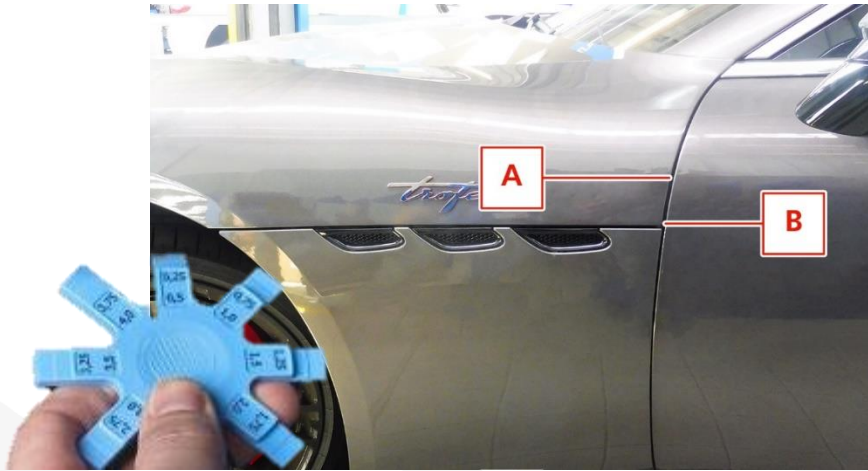
1. Always check ModisCS+ to see if the vehicle is involved in this action and if it has not been previously performed.
2. Using a proper gauge, check the relative positions of the front hood, fender, and door.

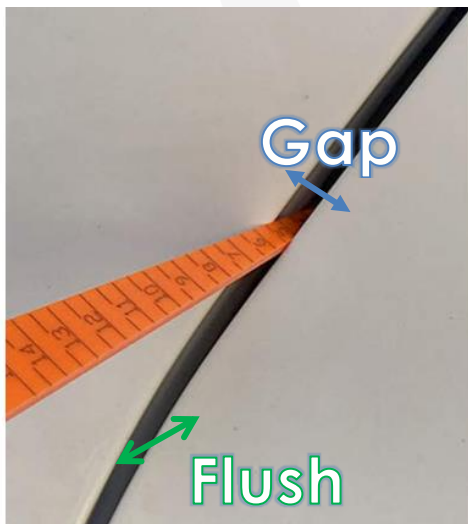
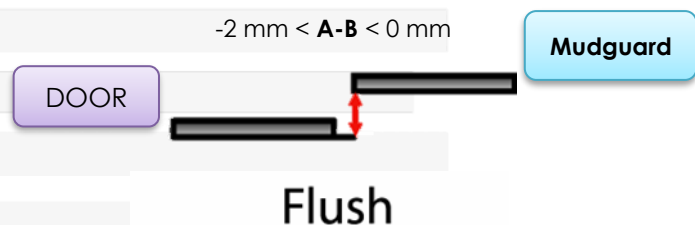
Flush&Gap Verification

GAP refers to the gap between the two profiles in the longitudinal direction, while **FLUSH** is the distance between the profiles in the transverse direction.

Always considering the **fender** as a **reference**, check:

- o from point **A** to point **B**:
 - the **GAP** (distance in the longitudinal direction) must be > 3.1 mm
 - The **FLUSH** (distance in the transverse direction) must be between 0 mm and -2 mm

3. If the measurements are within spec, no further adjustments need to be made.
 4. If one or more measurements do not fall within the range described, continue with the adjustment according to the following parameters.

5. If the **GAP** between **A and B** is < 3.1 mm, proceed with the **adjustment of the door** on the X axis by acting on the hinge fixings on the body side.

6. If the **FLUSH** between **A and B** is not between 0 mm and -2 mm, proceed with the adjustment **of the door** on the Y-axis on the hinge fixings on the door side.
