MAS004406 RU 24-35

RAPID UPDATE

Rapid Update 759 Granturismo GranCabrio – Intercooler Hose Clamp Check

DATE: October 15, 2024

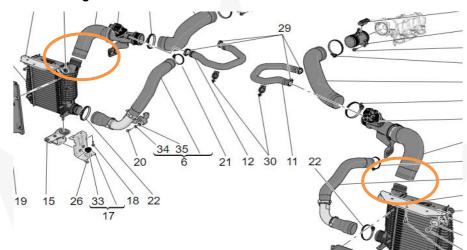
2. Open the front hood and check the clamps on the interface pipe between the turbocharger and the intercooler, on both the **right** and **left sides**.

3. For the **right side** it is not necessary to carry out any type of disassembly as it is easily visible.

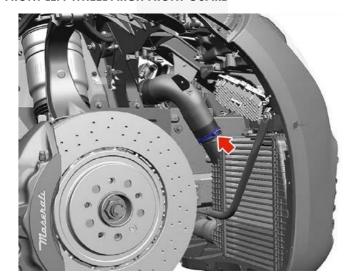
- 4. To check the left side instead, it is necessary to remove the left front wheel arch. Follow the instructions in the workshop manual.
 - a. 9.13.072 FRONT LEFT WHEEL ARCH FRONT GUARD

- 5. Evaluate the correct assembly of the clamp and if it is not correctly installed, replace the component.
- 6. To replace the component, refer to the correct workshop procedure reported in the manual:
 - a. 1.32.085 CLEAN AIR HOSE RH FIRST SECTION Removal-Refitting or Replacement
 - b. 1.32.086 LEFT CLEAN AIR HOSE FIRST SECTION Detachment-Reattachment or Replacement

NOTE: Replace **ONLY** the affected metal hose clamp, it is not necessary to replace the entire sleeve.
