Service Bulletin

Bulletin No.: 24-NA-158

Subject: Malfunction Indicator Lamp Illuminated with Active DTC P0102 and Possibly U060F and U1346 at the Mass Air Flow Sensor

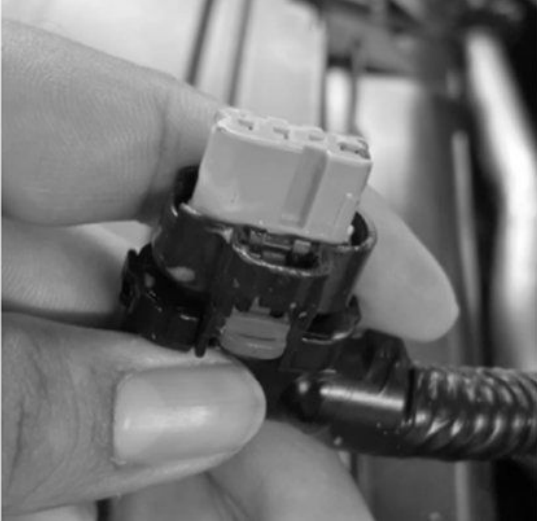
6719228

Involved Region or Country	North America
Additional Options (RPOs)	Equipped with Gas Engine 8-Cyl (RPO L84 or L87)
Condition	Some customers may comment on a malfunction indicator lamp illuminated. During diagnosis a technician may find an Active DTC P0102 and possibly U060F and U1346 at the Mass Air Flow Sensor.
Cause	The cause of the condition may be water infiltration in the MAF (Mass Air Flow) connector during assembly.
Correction	Complete the procedure below to correct the condition.

Replace the MAF sensor and MAF sensor connector with a service connector.

Refer to *Mass Airflow Sensor Replacement* in SI.

Note: Be sure to reuse the MAF sensor connector dress cover when completing the repair.
