Service Bulletin

Bulletin No.: 24-NA-166

Subject: DTC C1171 C1172 C1173 C1174 Tire Pressure Monitor Sensor Unable to Relearn Ethernet Cable Overlay for TCP OnStar Module

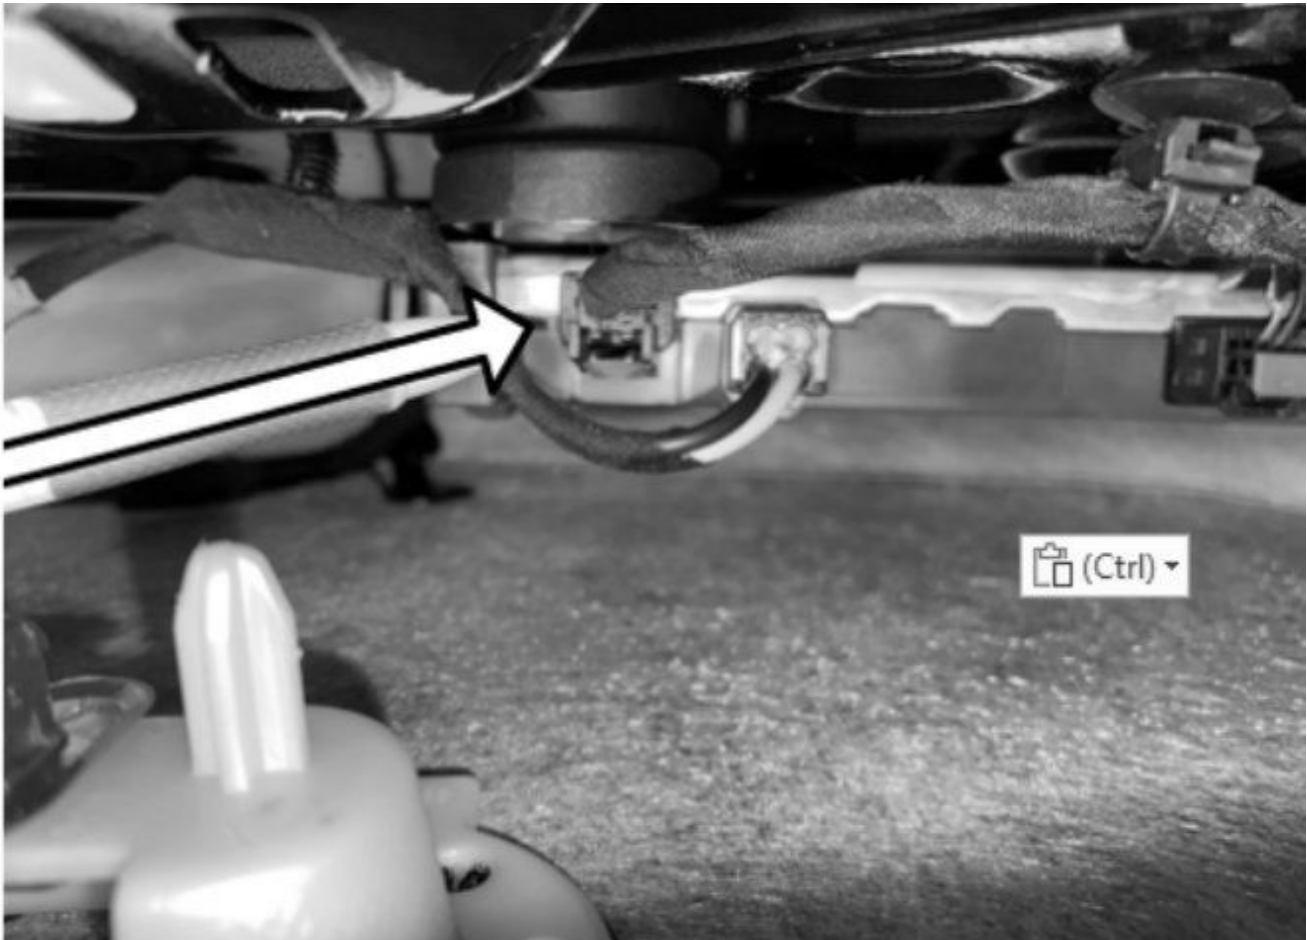
6720400

- Once confirmed the TPM sensors cannot be learned, gain access to the rear headlining trim panel. DO NOT remove the headlining trim panel, only lower it to gain access Refer to Headlining Trim Panel Replacement in SI. Disconnect the X7 connector and attempt to learn the TPM sensors.

If the TPM sensors are able to learn, continue with Ethernet Cable replacement. Otherwise follow SI.

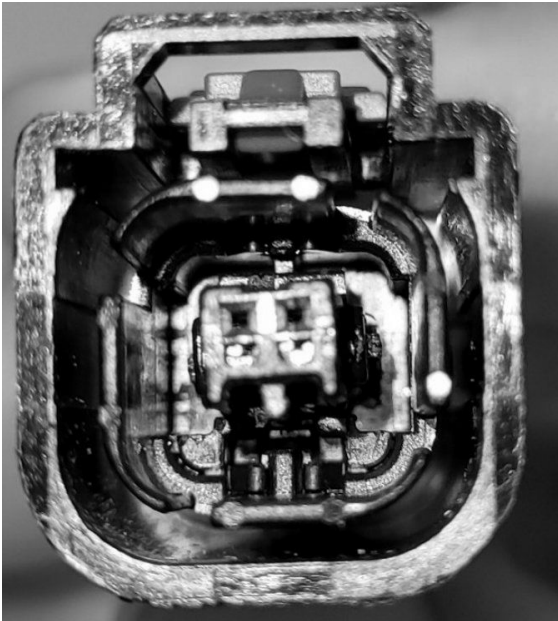
6720432

Following the middle ridge to the back, this is where the housing locks onto the cable.

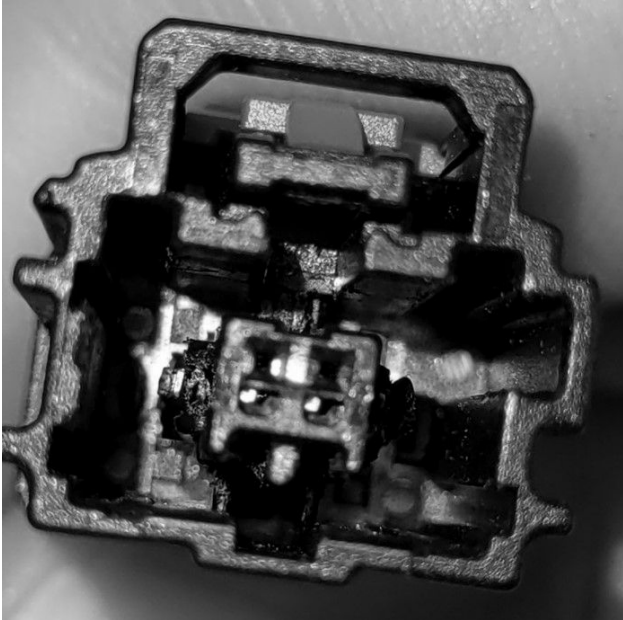
6720426

Following the middle ridge to the back, this is where the housing locks onto the cable.

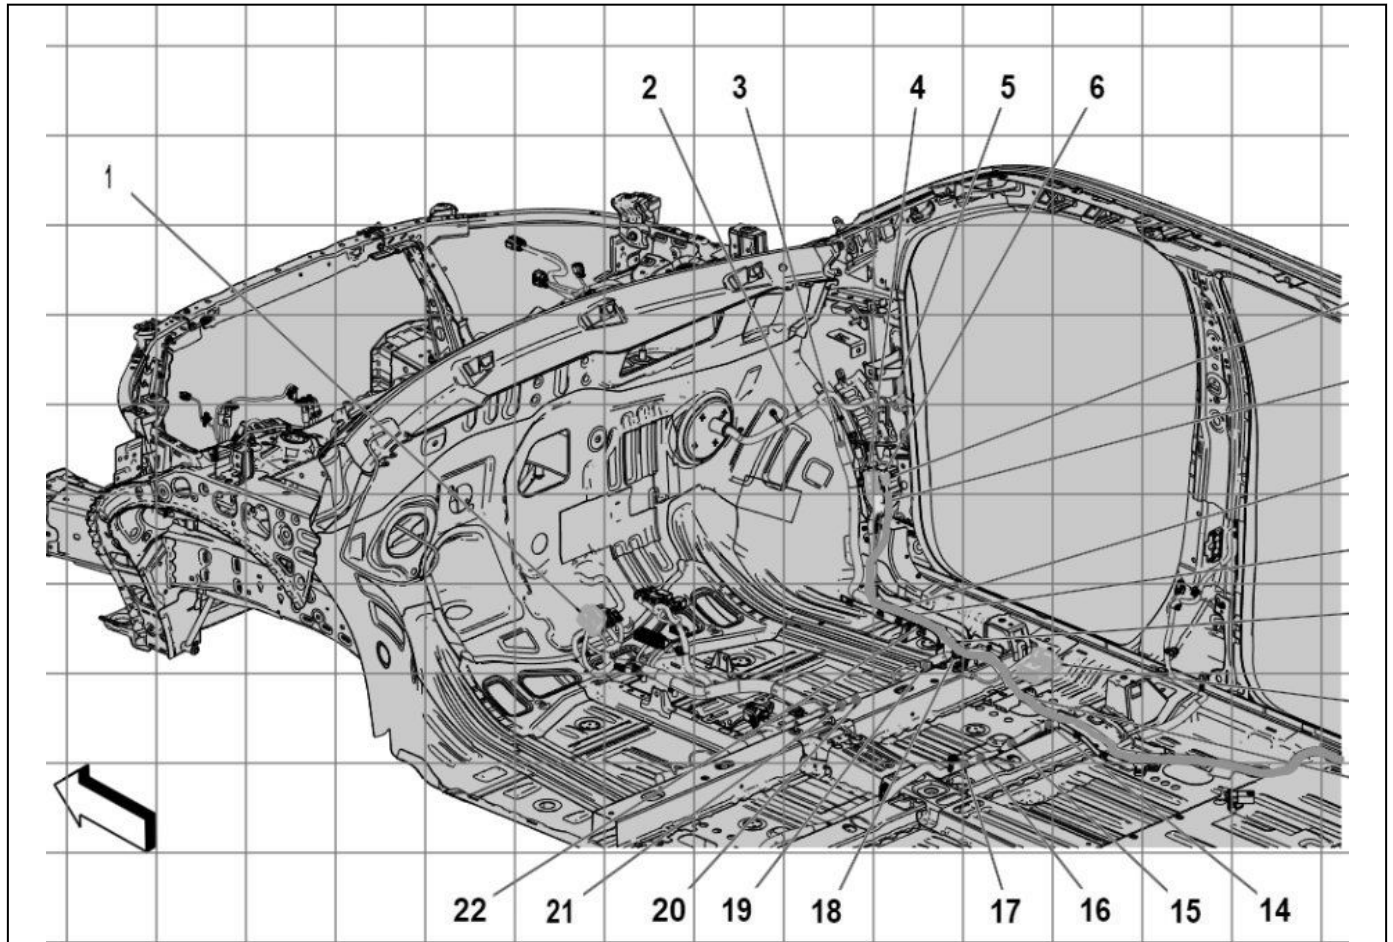
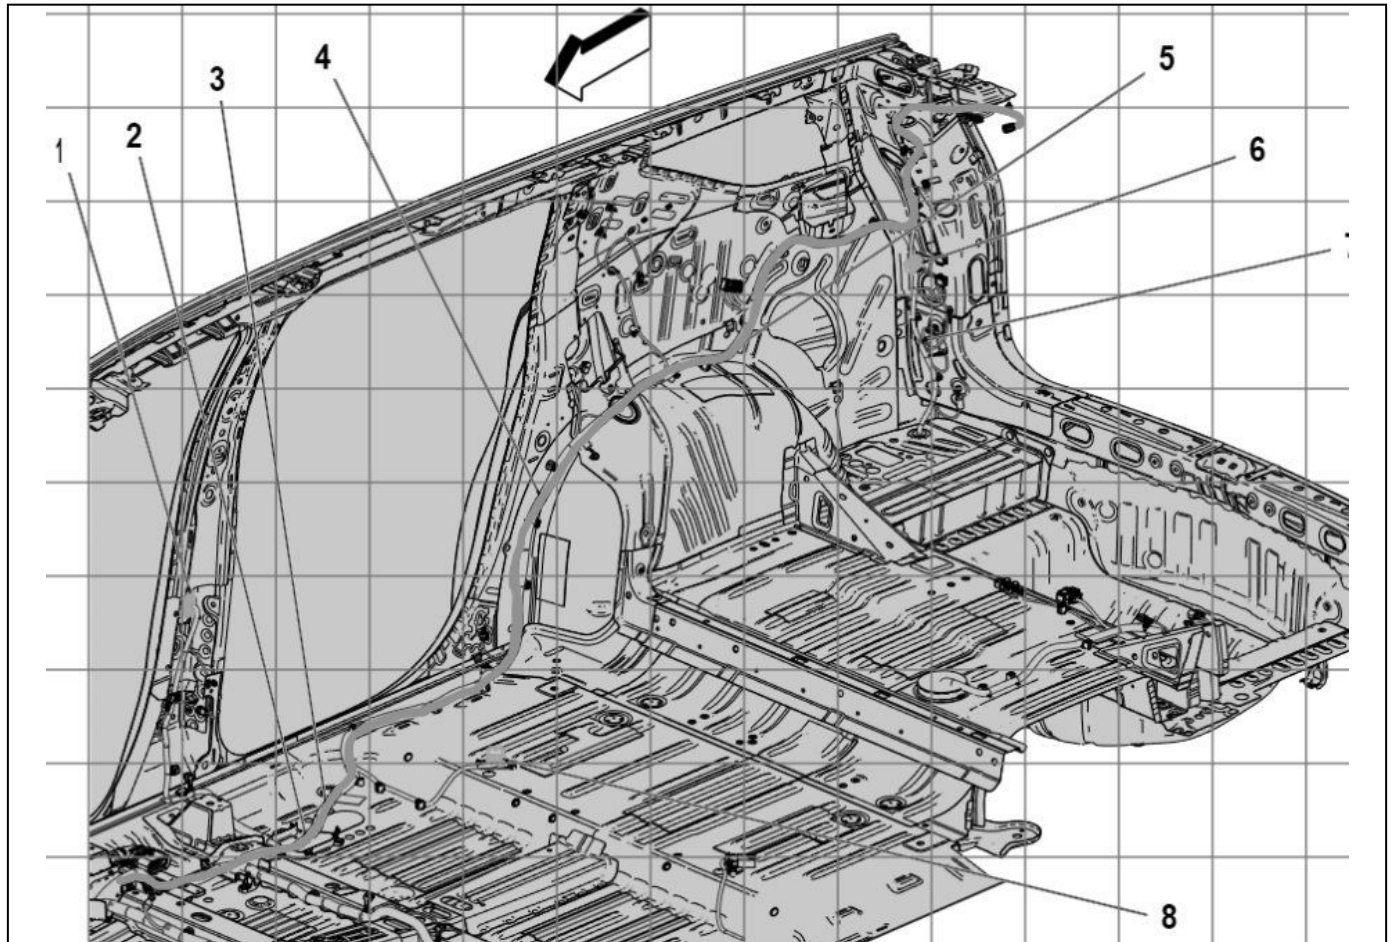
6706066

Note: Replacement Ethernet Cable routing shown in Green.

18. Begin to route the new Service cable starting at X205 and following the Body Wiring Harness running back towards the Telematic Control Module. Use the diagrams above to reference cable routing.
