# Service Bulletin

Bulletin No.: 24-NA-182

**Subject: Vibration/Rattle at 1800-2000 RPM**

Brand:	Model:	Model Year:		VIN:		Engine:	Transmission:
		from	to	from	to		
Chevrolet	Equinox	2025	2025	—	—	—	—

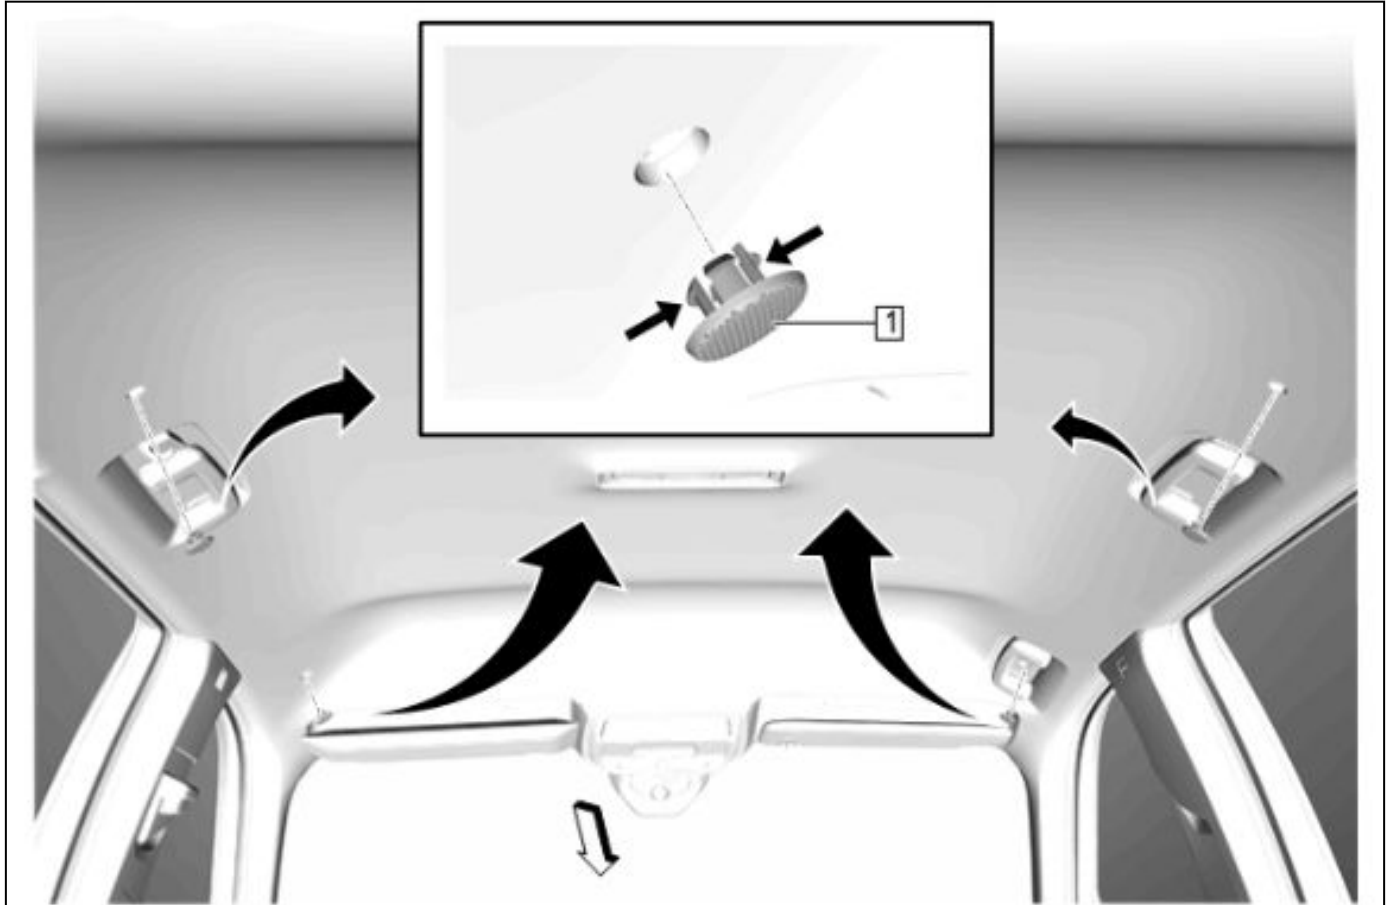
6679105

<b>Involved Region or Country</b>	North America
<b>Condition</b>	Some customers may comment on a vibration or rattle noise in the body of the vehicle, with the engine at around 1800-2000 rpm, under light load.
<b>Cause</b>	The cause of the condition may be that one or more active noise cancellation (ANC) microphones are not fully seated in their headliner retainer, causing the ANC system output to the speakers to vibrate/rattle the body.
<b>Correction</b>	Test drive the vehicle to verify the condition. Then, inspect for properly positioned ANC microphones in all 4 locations of the headliner. If any are found to be out of position, lower the headliner and fully install the microphone(s) into the retainers.

1. With the car in Drive and the brakes firmly applied, raise the engine RPM to the range the customer hears it in. Once the vibration is active, maintain the RPM and crack open the driver's door. This will disable the ANC system. If the vibration went away, continue to step 2. If the vibration remains, continue with diagnosis.

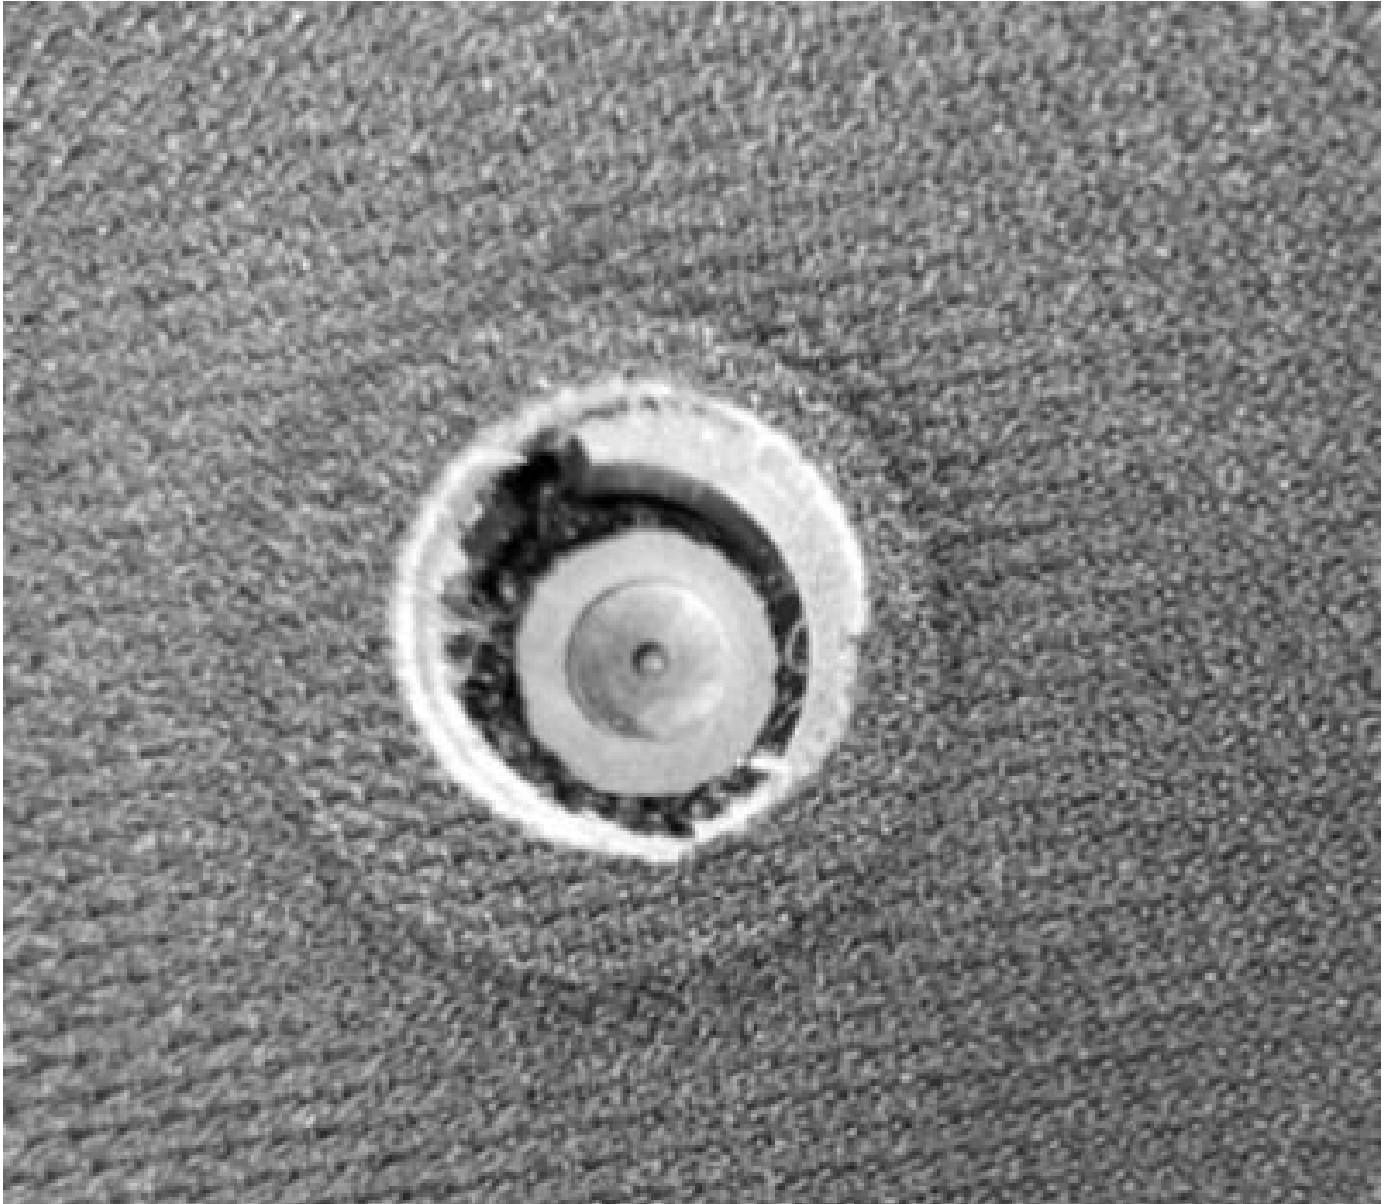
2. Use a suitable plastic trim tool to release the retaining tabs and remove the ANC microphone grilles (1) from the headliner. Look for any microphones not present, or out of position. The mic shouldn't move if gently pushed.

- Follow *Headlining Trim Panel Removal and Installation* in SI for instructions on how to lower the headliner. The headliner does not require removal to access ANC microphones. Only lower the corner(s) that require the microphone to be properly retained.

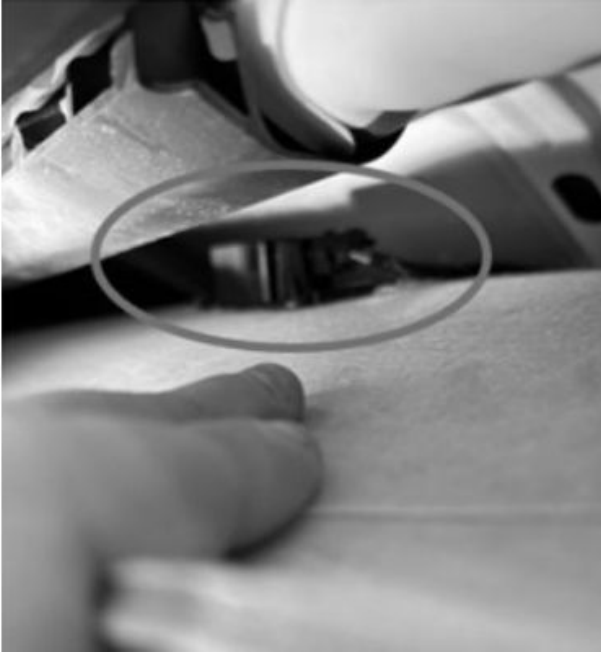
6727501

Example of properly located ANC microphone.
