# Service Bulletin

Bulletin No.: 19-NA-129

**Subject: Squeak and/or Clunking Noise from Rear of Vehicle**

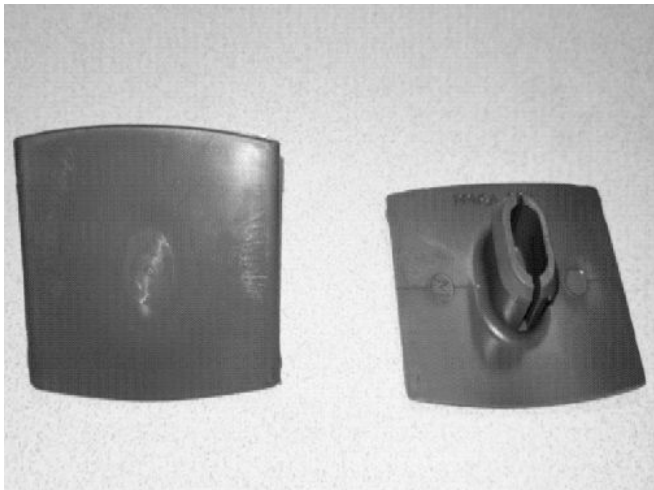
5341853

1. Raise the vehicle on a frame lift-type hoist. Refer to *Lifting and Jacking the Vehicle*, in SI.
2. Inspect the rear leaf springs and shackles for damage.
  - If damage has been found, refer to *Rear Spring Shackle Replacement or Leaf Spring Replacement (1500)*, in SI.
  - If damage has NOT been found, proceed to the next step.
