Service Bulletin

Bulletin No.: 22-NA-182

Subject: Information on 6L80, 6L90, 8L90, 10L80, 10L90, 10L1000 Equipped Vehicles with A Harsh Shift, Shudder, Surge, Stall, Neutral/Flare, Transmission Overheating and/or High Transmission Fluid Temperature

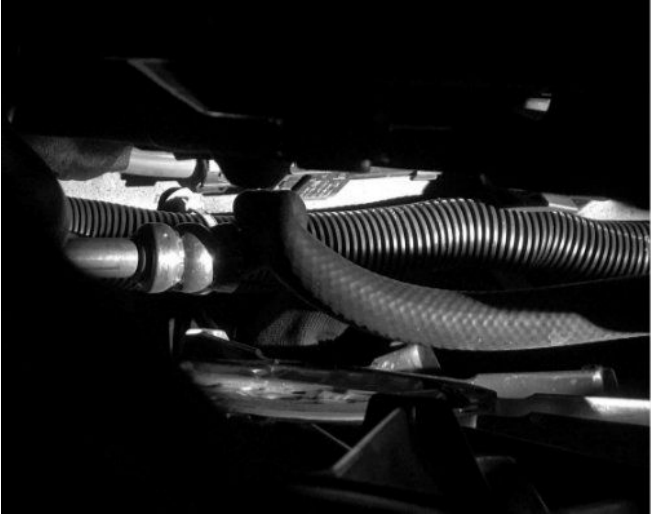
<p>5758376</p> <p>Inspect for a twisted cooler line, example shown in the graphic above.</p> <p>In some cases, it may be necessary to remove the under-body panels in order to clearly see the cooler lines.</p> <ul style="list-style-type: none"> • If the cooler line is twisted, disconnect the cooler line from the transmission auxiliary cooler and untwist it, then reconnect the cooler line. • If the cooler line remains misshaped after untwisting, the cooler line should be replaced then check the transmission fluid level following SI. Add fluid if needed. • If no concerns are found with the rubber line being misshaped, check the transmission fluid level following SI. Add fluid if needed. <p>The Thermal Bypass Valve (TBV) may be the cause of the overheat if a cooler line is not twisted or misshaped. The TBV will open at the following temperatures for the models listed in this TSB:</p> <ul style="list-style-type: none"> • 6 Speed (6L80, 6L90) - 158F (70C) - TBV is external to the transmission. • 8 Speed (8L90) - 194F (90C) – TBV is external to the transmission. • 10 Speed (10L80, 10L90, 10L1000) – 143F (61C) – TBV is within the valve body on all listed applications except those equipped with 3.0 (LM2) (LZ0) Diesel. The (LM2) and (LZ0) Diesel, the TBV is on the frame rail, external to the transmission and opens at 194F (90C).
