## **Addition of reinforcement plate to LG Subframe**

The 01-04122-004-00 reinforcement plate has been added to the 15-03529-001-00 LG Subframe Assy in revision C. The following directions are for adding (4) 01-04122-004-00 reinforcement plates to previous revisions of the LG Subframe assembly.

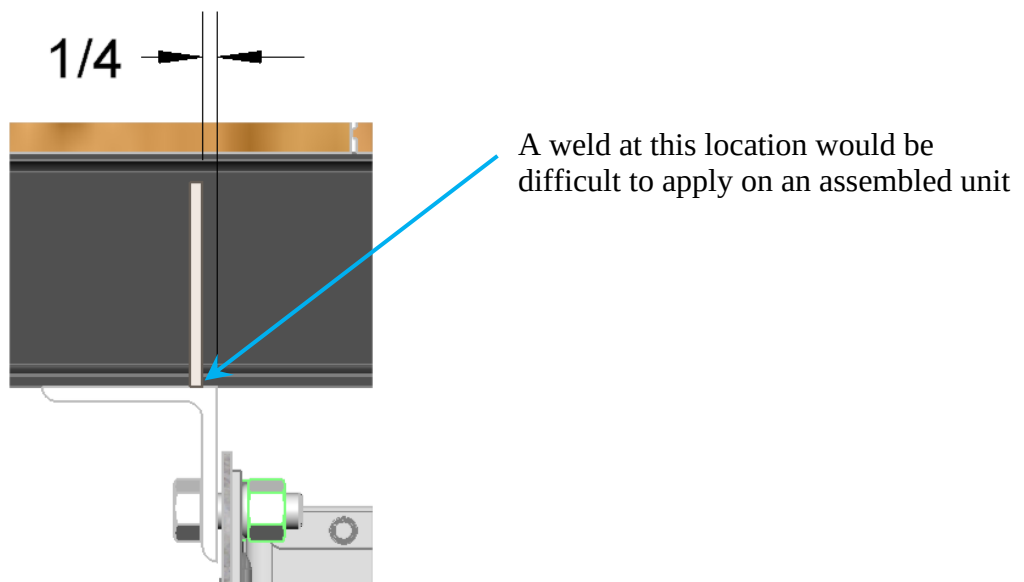
The 15-03529-001-00 LG subframe has the 01-04122-004-00 reinf plates installed on top and 1/4in inboard the face of the angle.
