Service Bulletin

Bulletin No.: 23-NA-142

Subject: No Forward Gear When Shifting from Park to Drive and/or Reverse to Drive

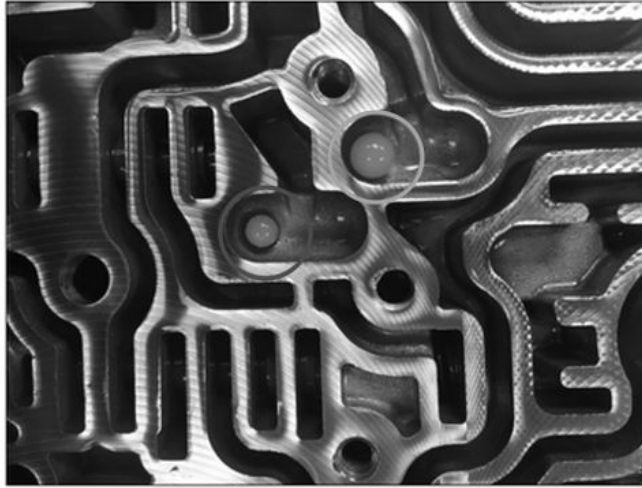
6404322

<p>Involved Region or Country</p>	<p>North America, Europe, Kazakhstan, Russia, Middle East, Iraq, Israel, Palestine, Chile (West), Colombia (West), Ecuador (West), Paraguay (West), Peru (West), Uruguay (West), Japan, China - SGM</p>
<p>Condition</p>	<p>Some customers may comment that the vehicle won't move forward after shifting into Drive from Park or Reverse. Some customers may also comment that reverse appears to work properly. Note: Once moving in drive. There should be no concern until the next shift cycle.</p>
<p>Cause</p>	<div data-bbox="531 383 1182 994" data-label="Image"> <p>A microscopic view of a circular metal component, likely a check ball seat, showing a chamfered edge. A thin black line is drawn across the chamfered surface to indicate its profile.</p> </div> <div data-bbox="1422 999 1485 1021" data-label="Text"> <p>6404748</p> </div> <p>This condition may be caused by a Spacer Plate in the valve body that does not meet the specification for chamfer across the entire circumference of the coined check ball seat.</p> <div data-bbox="560 1144 1214 1626" data-label="Image"> <p>A microscopic view of a circular metal component, likely a check ball seat, showing a burr or defect on the edge. A small circle is drawn around the defect to highlight it.</p> </div> <div data-bbox="1422 1693 1485 1715" data-label="Text"> <p>6404809</p> </div> <ul style="list-style-type: none"> - The seat for the check ball is out of spec relative to coin depth. This potentially can cause burrs, dents, or dings, which could cause the plastic check ball to wear prematurely. <p>Note: School buses, some of which shift to Park at each student stop, may exhibit the earliest signs of failure.</p> <ul style="list-style-type: none"> - The #1 check ball has a high duty cycle and when combined with the issue, there is a possibility for the check ball to wear and then become stuck or pass through the spacer plate.

- As indicated in the graphic above, the check ball circled in RED has prematurely worn down. It should be the same diameter as the check ball circled in GREEN.

Correction	Replace the spacer plate and check ball.
-------------------	--
