GROUP	MODEL
ELE	2023MY Sportage (NQ5a) w/ AVNT Head Unit
NUMBER	DATE
355	October 2024

TECHNICAL SERVICE BULLETIN

AVNT COAXIAL CABLE REPLACEMENT

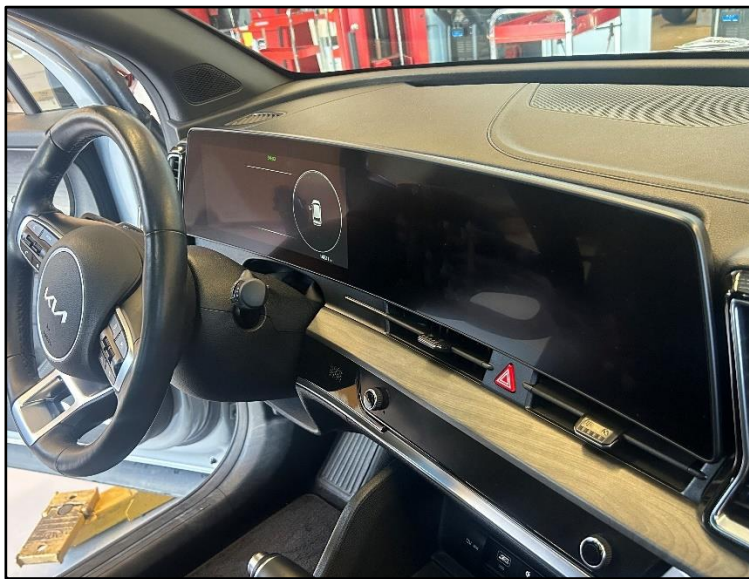
This bulletin provides the procedure to replace the Audio Video Navigation Telematics (AVNT) head unit coaxial cable on some 2023MY Sportage (NQ5a) vehicles produced from August 5, 2021 through May 25, 2023. The affected vehicles may experience the AVNT screen flickering 'ON/OFF' due to an intermittent contact of the coaxial cable connector with the AVNT head unit. Follow the procedure outlined in this publication to replace the AVNT head unit coaxial cable on the applicable vehicle.
