WARRANTY BULLETIN

NO: D-23-04

SUBJECT: 2018 - 2024 (Current) Jeep
Wrangler (JL) and 2020 - 2024 (Current)
Jeep Gladiator (JT) - Corrosion Warranty
Claim Simplification (Rev. F)

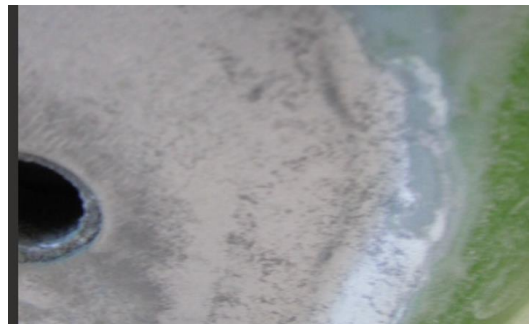
1. Pitting found after sanding the affected area (Fig. 1)

Pitting Found After Sanding Example (Fig. 1)

Note: If pitting is found during the sanding process, please use LOP 23-75-XX-XX for up to 0.5 hours in conjunction with the 23-85 replacement LOP.

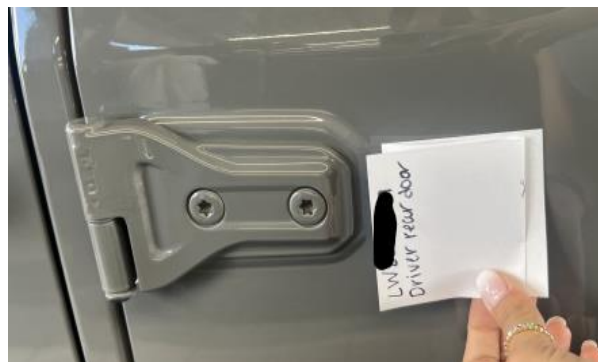
VIN Example (Fig. 3)

Dealers will need to take photos of the affected areas identified during the inspection to support the repair. A clear photo of the corrosion is needed and **MUST** include the VIN and affected body panel. The VIN and affected body panel can be included on a sticky note, written with a grease pen, a copy of the RO in the photo, masking tape, etc. (Figure 3)
