# FCA CARIBBEAN WARRANTY BULLETIN

**NO:** ID-23-03

**DATE:** October 16, 2024

**SUBJECT:** 2018 - 2024 (Current) Jeep  
Wrangler (JL) and 2020 - 2024 (Current)  
Jeep Gladiator (JT) - Corrosion Warranty  
Claim Simplification (Rev. G)

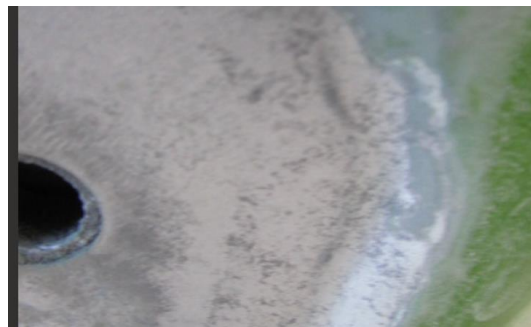
1. Pitting found after sanding the affected area (Fig. 1)

**Pitting Found After Sanding Example (Fig. 1)**

Note: If pitting is found during the sanding process, please use LOP 23-75-XX-XX for up to 0.5 hours in conjunction with the 23-85 replacement LOP.
