STAR ONLINE PUBLICATION

Case Number: S2408000063 Rev. B

Symptom/Vehicle Issue: Service Hybrid Electric Vehicle System Warning Message And Light Are Displayed. B273C-00 - Digital Crash Input Set In HCP

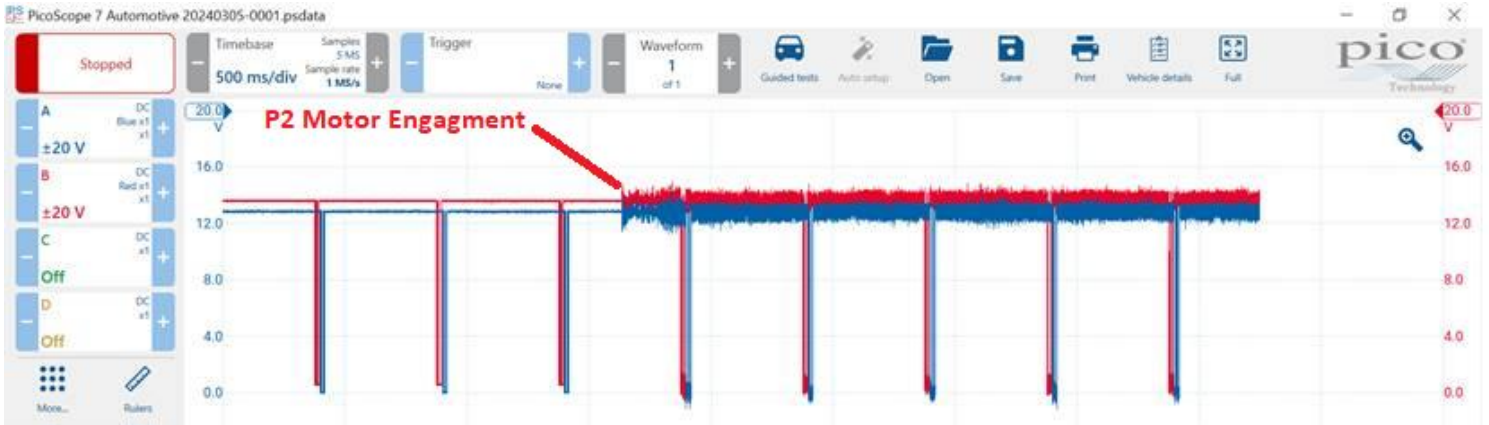
This issue may be caused by Electromagnetic Interference (EMI) from the High Voltage (HV) P2 Motor and associated HV harnesses which can transfer inductive voltage/electric noise onto the R41 - Airbag Deployment Signal and R414 - Airbag Deployment Signal 2 circuits. This inductive voltage/electric noise corrupts the health status signal and causes the B273C-00 – Digital Crash Input DTC to set.

Diagnosis: Connect an oscilloscope such as the Mopar PicoScope to the R41 and R414 circuits. When the P2 motor engages and begins operating, look for a distinctive change in the voltage pattern which would confirm the presence of induction voltage/ electrical noise, See Fig. 1. Some EMI on these circuits is expected during normal operation; however, some vehicles will exhibit more than others. If the electric noise is beyond the acceptable threshold, B273C-00 – Digital Crash Input will set in the HCP almost immediately after the noise is detected on the oscilloscope.

Fig. 1 :Electrical Noise on R41 and R414 Circuit After P2 Motor Engagement

Repair: As stated, some EMI is normal and will be observed on all vehicles and will not induce any faults. However, if B273C-00 only becomes Active when electrical noise is detected on R41 and R414 with an Oscilloscope. Excessive EMI on these circuits should be considered the root cause.

A HCP, AHCP and PCM software update and wiring harness repair is expected to be released in the form of a TSB/RSU in Q4 2024. This software will increase the HCPs ability to detect a valid Digital Crash Input health signal when excessive EMI is present. The wiring harness repair will help eliminate excessive EMI.

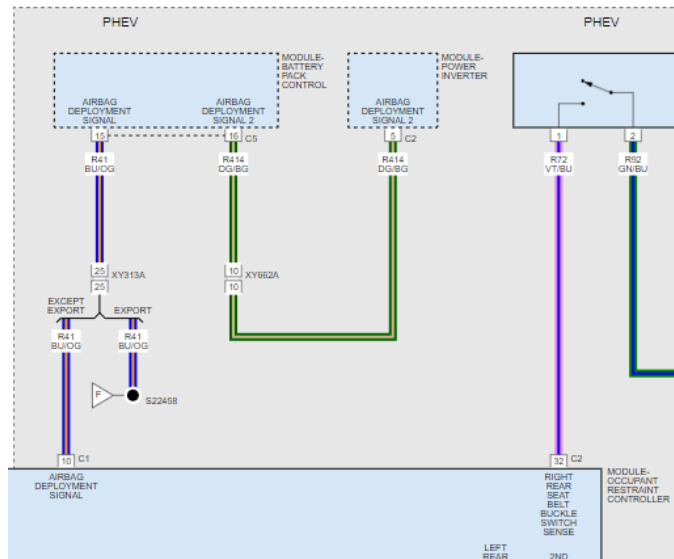
Fig 2: Airbag Deployment Signal Circuits (R41 and R414)
