SIB 65 26 24

2024-10-16

KNEE AIR BAG CCM G01 VARIANT WIRE HARNESS REPAIR

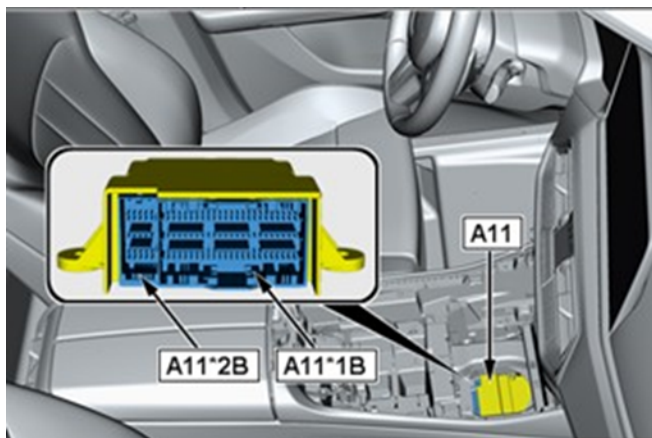
Check the ACSM module for signs of corrosion within the electrical connectors.

2- Remove the **center console** as per **Repair Instructions 51 16 165** to access the Air Bag Control Module **A11 (ACSM)** wiring connector (**A11*2B**).

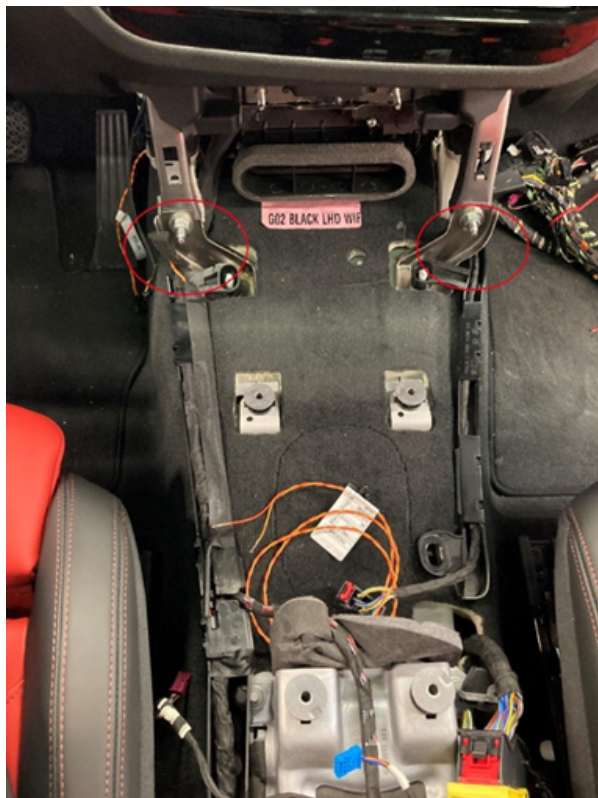
Over time, the wiring harness going to the knee air bag(s) can rub against the metal support tubes for the instrument panel, chafing and damaging the wiring.

5- Apply felt tape to the locations circled.

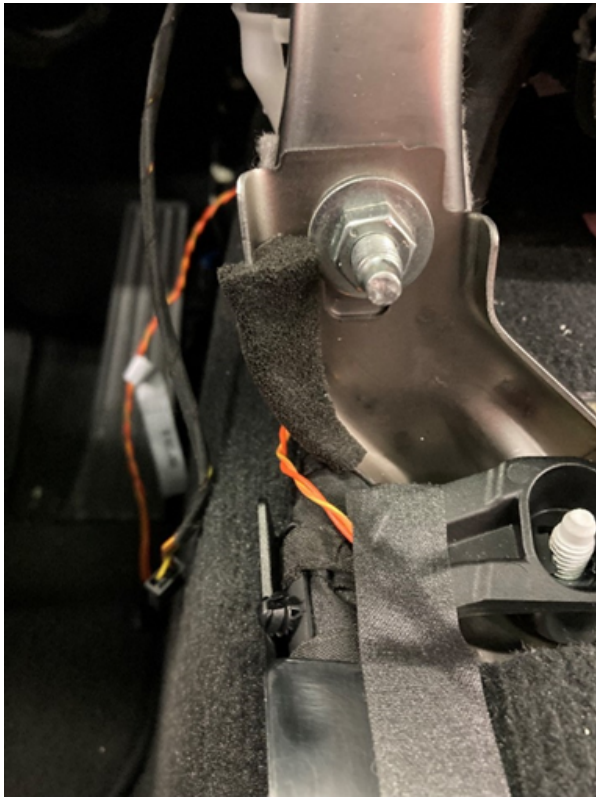
6- The knee air bag wiring should be protected from chafing at the dash support bracket.

Glue the felt generously onto the support tube or to the corresponding edge.
