SIB 84 03 24

## RETROFIT A SERVICE ACCESS FOR THE TELEMATICS CONTROL MODULE – F48

E-Series	Model Description	Model Years
F48	X1 Sports Activity Vehicle	2016 to 2022

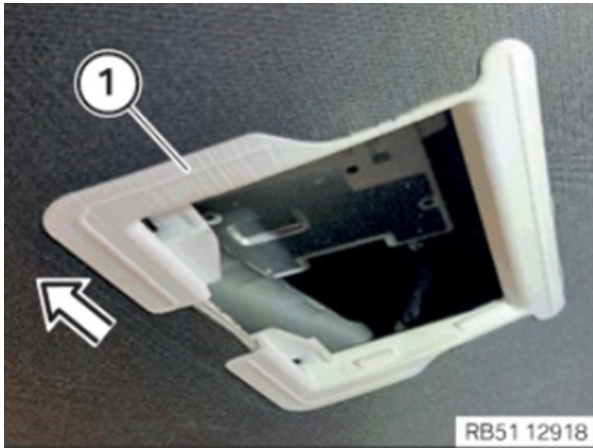
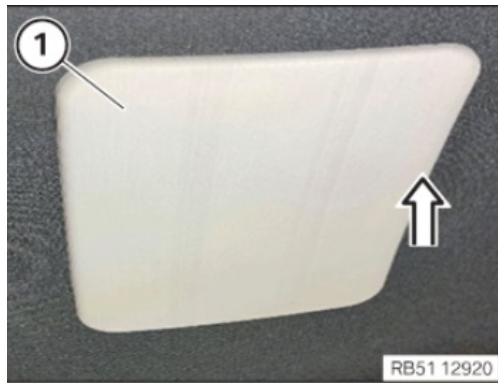
The retrofit simplifies the service access procedure, helping to reduce the time and effort that is required.

2. Retrofit the service access assembly in the headlining per **Repair Instructions 84 10 527 - Retrofitting telematics control unit service access (Incl. replace emergency battery) (after vehicle diagnosis)**.
