HYUNDAI
Technical Service Bulletin

| GROUP BODY ELECTRICAL | NUMBER 24-BE-014H |
| DATE OCTOBER 2024 | MODEL(S) Accent (HC) Tucson (TL) |

SUBJECT: AIRBAG CONTROL UNIT (ACU) REPLACEMENT
(WARRANTY EXTENSION TXXQ)

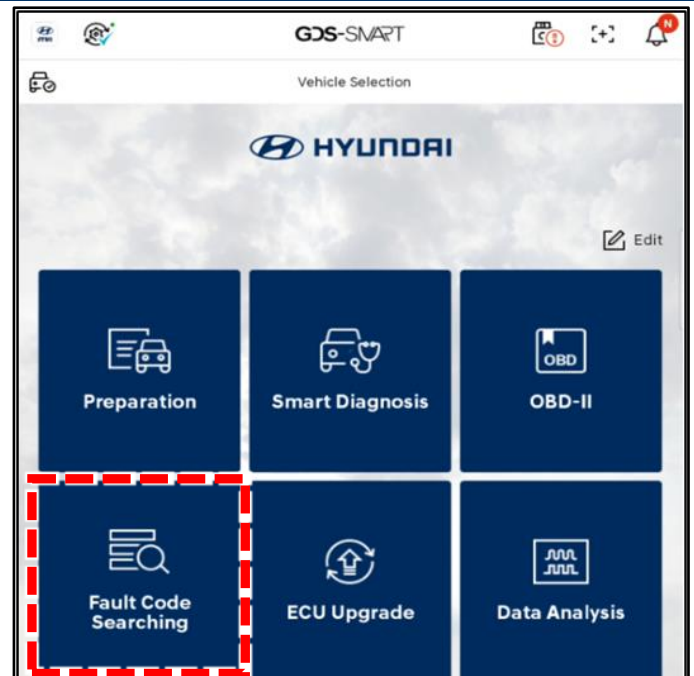
1. Connect the VCI into the vehicle's DLC connector under the driver side and run Fault Code Searching to perform Diagnostics.
