**Technical Service Bulletin (TSB)**  
**C-Pillar Paint Mismatch**

| REFERENCE: | TSB: 23-054-24<br>GROUP: 23 - Body | Date: | October 15, 2024 | REVISION: | — |
| VEHICLES AFFECTED: | 2024 (VF) RAM Pro Master<br>This bulletin applies to vehicles built on or after April 06, 2024 (MDH 0406XX) and on and before August 12, 2024 (MDH 0812XX) equipped with one of the following: <ul style="list-style-type: none"><li>Cashmere Pearl Coat (Sales Code PFS)</li><li>Granite Crystal Met. Clear Coat (Sales Code PAU)</li><li>Bright Silver Metallic Clear Coat (Sales Code PS2)</li></ul> | | | MARKET APPLICABILITY:<br><div><input checked="" type="checkbox"/> NA<input type="checkbox"/> MEA</div> <div><input type="checkbox"/> SA<input type="checkbox"/> IAP</div> <div><input type="checkbox"/> EE<input type="checkbox"/> CH</div> | |

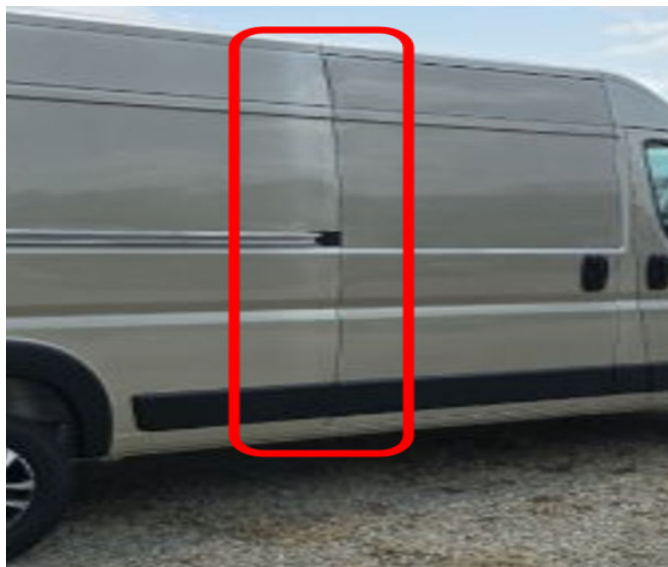
| CUSTOMER SYMPTOM: | The customer may comment on the following: <ul style="list-style-type: none"><li>Exterior paint color on leading edge of right body side panel mismatches the C-Pillar <a href="#">Fig. 1</a>.</li></ul> | | | | |
| CAUSE: | Machine overspray during production | | | | |

**Fig. 1**  
Paint Mismatch

This bulletin involves refinishing the right side sliding door and rear body side panel.
