# Service Bulletin

Bulletin No.: 24-NA-182

**Subject: Vibration/Rattle/Boom at 1800-2000 RPM**

Brand:	Model:	Model Year:		VIN:		Engine:	Transmission:
		from	to	from	to		
Chevrolet	Equinox	2025	2025	—	—	—	—

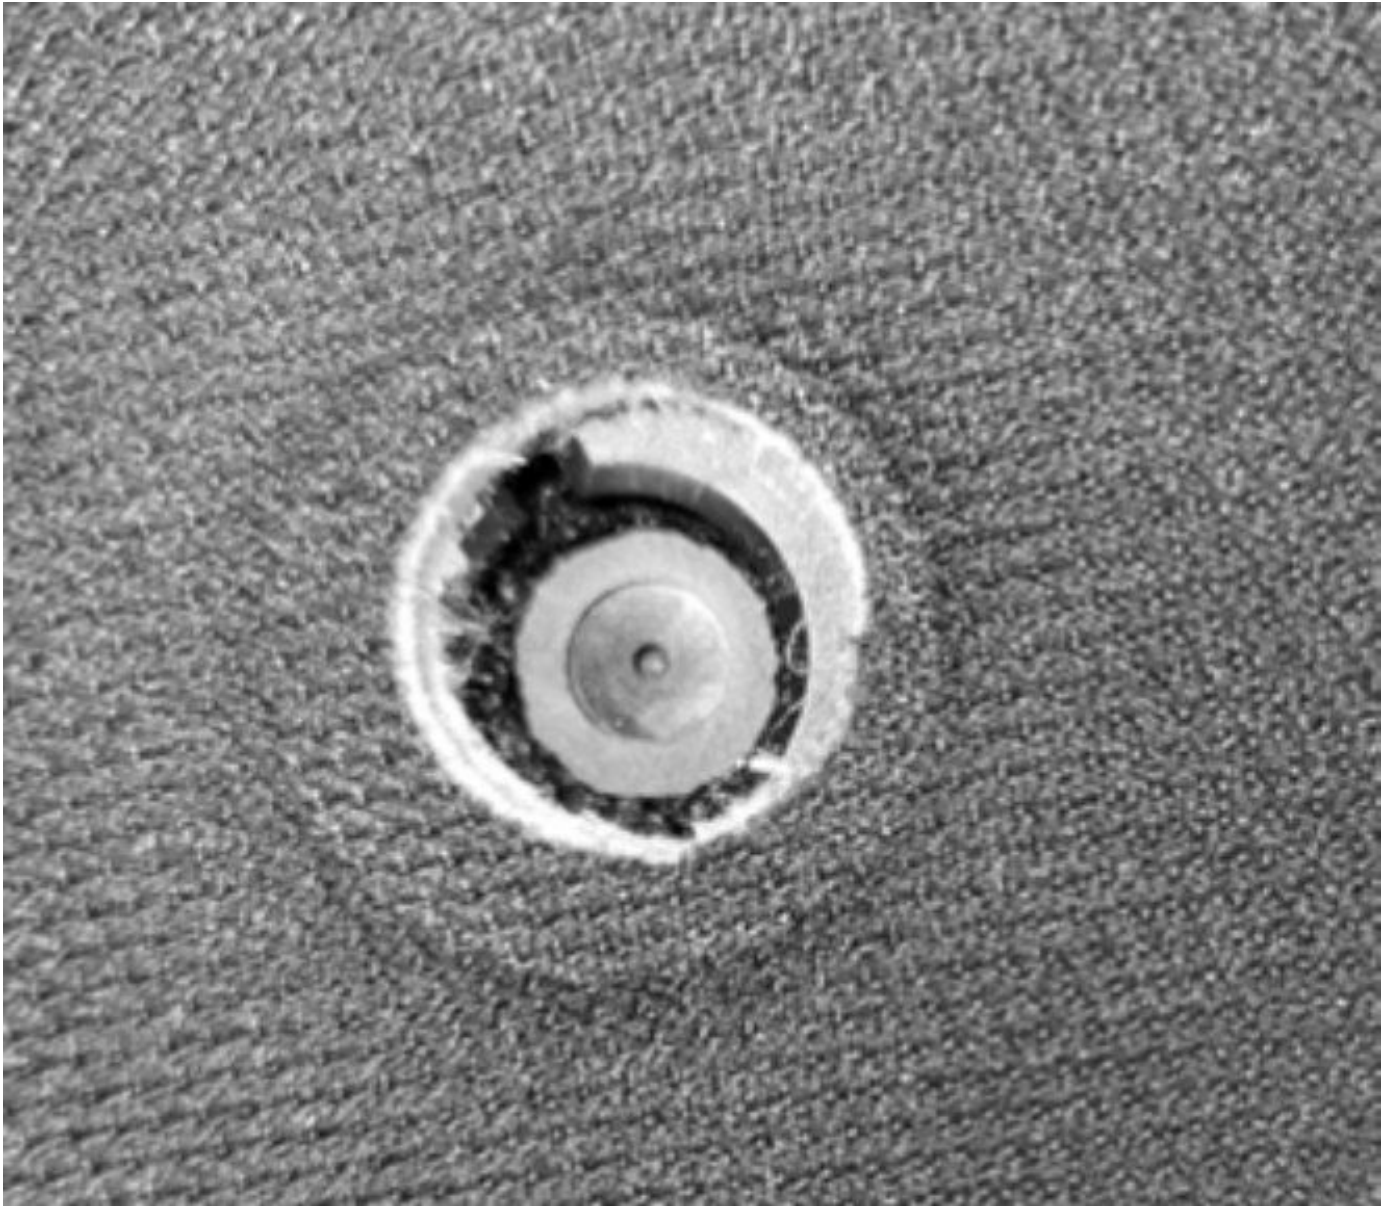
6727498

2. Use a suitable plastic trim tool to release the retaining tabs and remove the ANC microphone grilles (1) from the headliner. Look for any microphones not present, or out of position. The mic shouldn't move if gently pushed.

Example of properly located ANC microphone.
