# Service Bulletin

Bulletin No.: 24-NA-186

**Subject:** Information on Engine Vibration after Engine Mount or Bracket Replacement

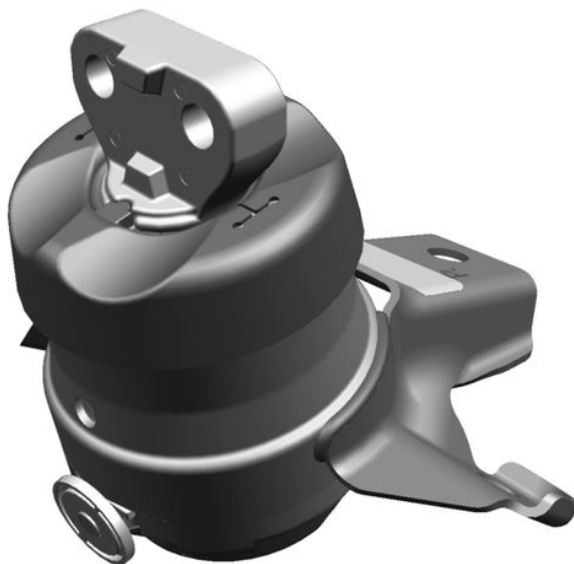
6729740

- Vehicles with J21 have the "old" mount system.

If parts between these systems are mixed, vibration will result.

Inspect both engine mounts for correct components and if any incorrect components are found, replace the incorrect components only. Refer to the parts catalog notes when ordering mounts and components.

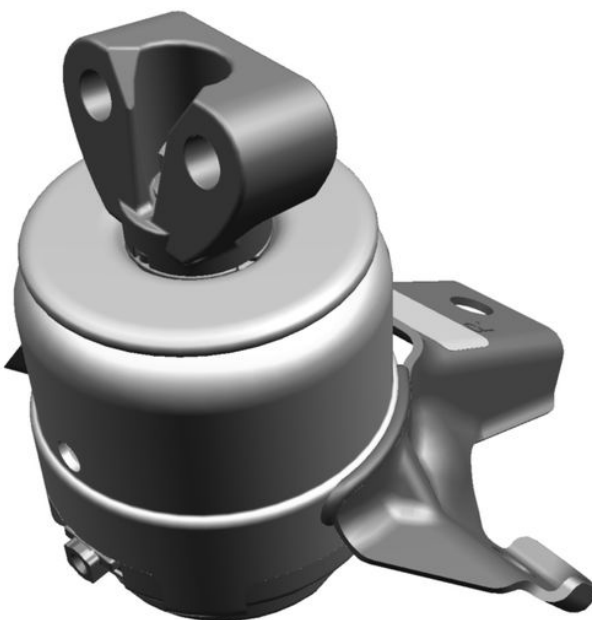
6729741

- Vehicles with J22 have the "new" mount system.
