Service Bulletin

Bulletin No.: PIE0794C

Subject: Engineering Information - (EI Lite) - (Pictures Only) Oil Leaking from Oil Pan

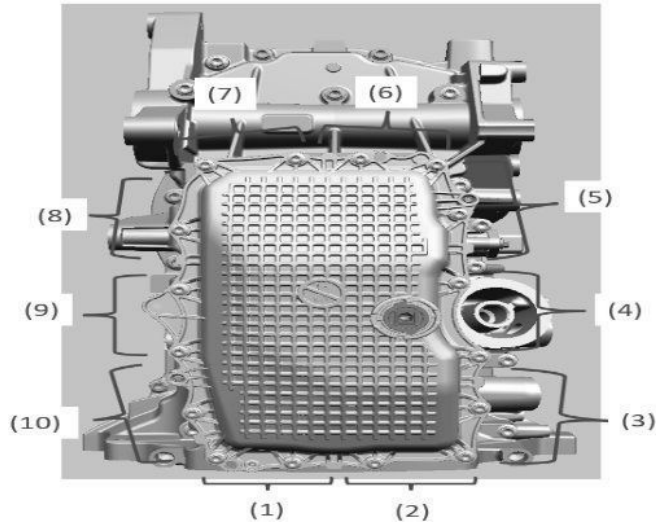
6664231

CT4 and CT5 Oil Pan

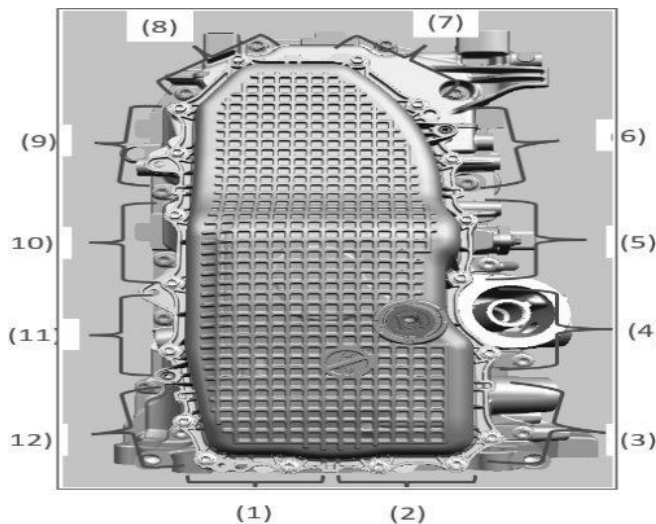
6664230

XT4, XT5, XT6, Blazer, and Acadia Oil Pan

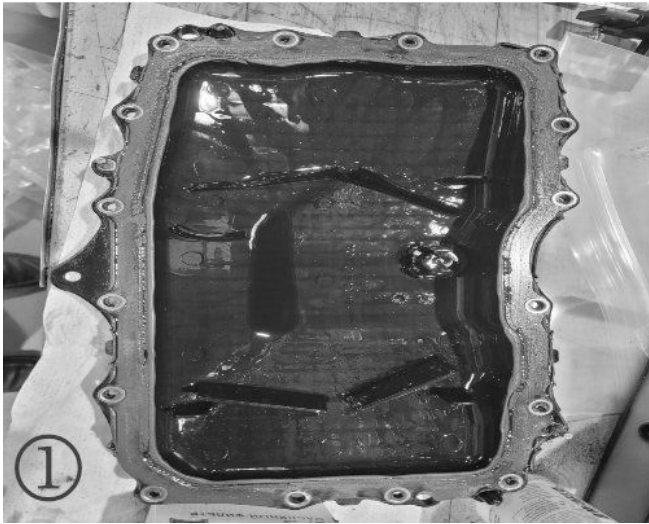
6713713

Make an assessment based on which leak "zone" the oil is originating from on the oil pan and take a clear picture. Circle the identified leak area on a printout or PDF of the provided oil pan call out locator.

1. Take a clear picture of sealing surface of the oil pan (1), as shown in picture above.
