INFINITI

TECHNICAL SERVICE BULLETIN

ITB19-024D

DTC B00A0-00 STORED

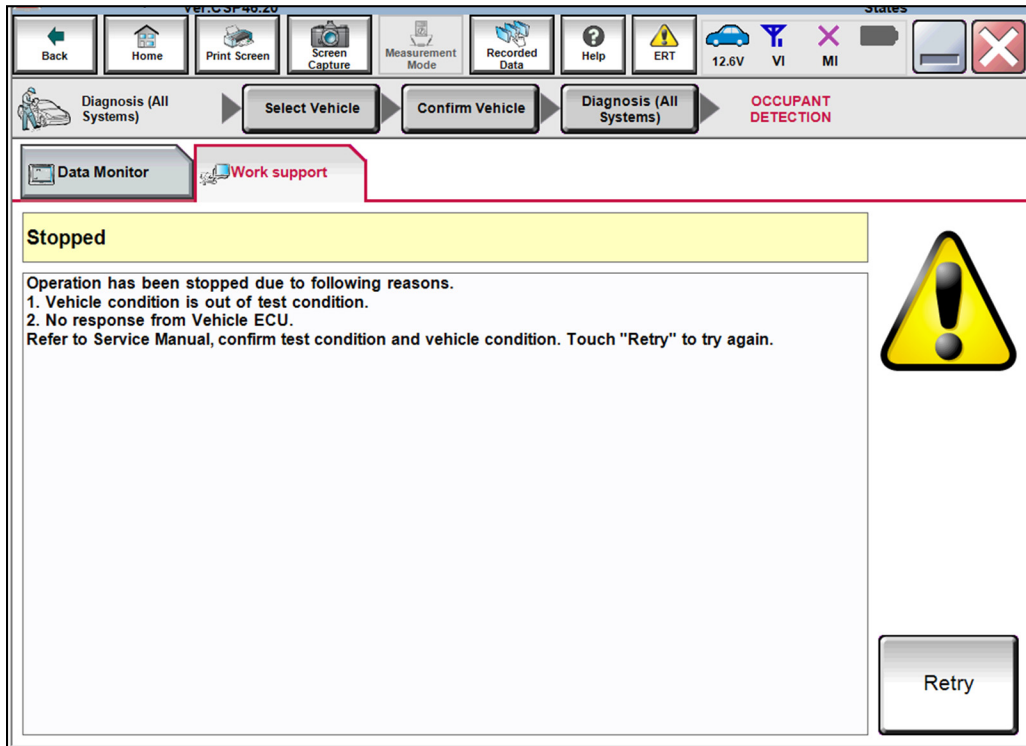
Figure 1

DTC B00A0-00 (OCCUPANT DETECTION SENSOR UNIT) is stored,

OCS zero point reset cannot be performed,

The following screen displays:

1. Check the Occupant Classification System (OCS) control unit using the ODS Analysis tool software.
 - Refer to **SERVICE PROCEDURE** on page 4.

HINT: "OCS" also may be referred to as "ODS".
2. Perform "75-Zero RESET".
