TECHNICAL SERVICE BULLETIN

Classification: RS19-004D	Reference: NTB19-071D	Date: September 19, 2024
------------------------------	--------------------------	-----------------------------

DTC B00A0-00 STORED

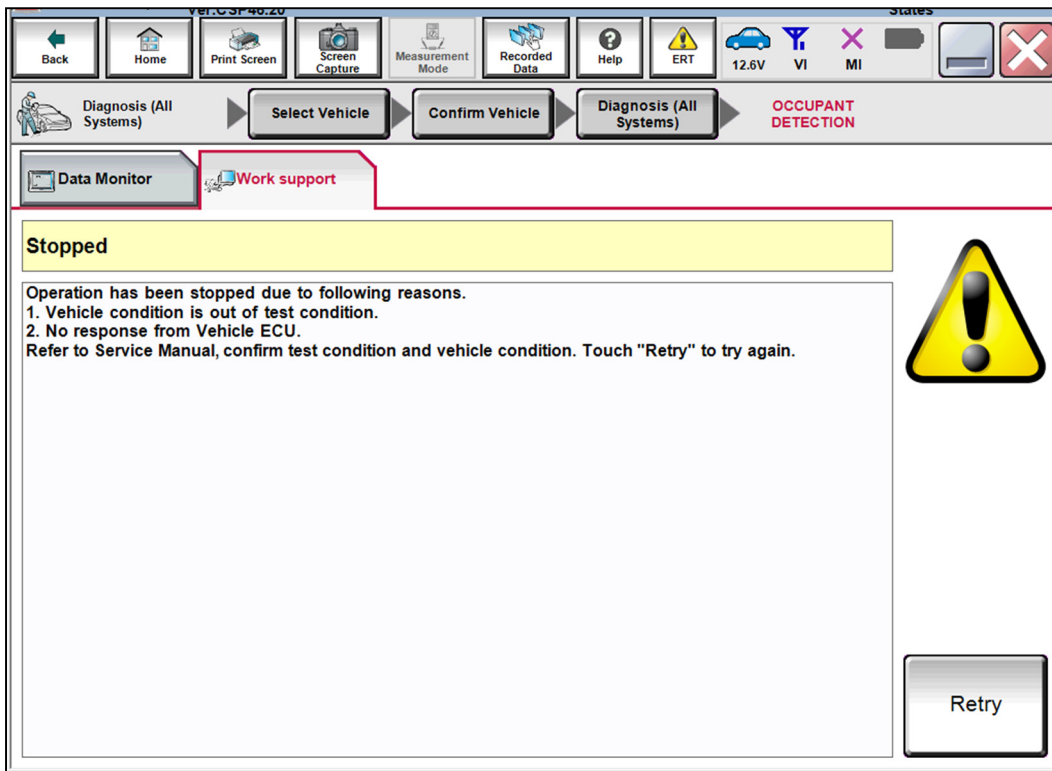
Figure 1

DTC B00A0-00 (OCCUPANT DETECTION SENSOR UNIT) is stored,

OCS zero point reset cannot be performed,

The following screen displays:

1. Check the Occupant Classification System (OCS) control unit using the ODS Analysis tool software.
 - Refer to **SERVICE PROCEDURE** on page 4.

HINT: "OCS" also may be referred to as "ODS".
2. Perform "75-Zero RESET".

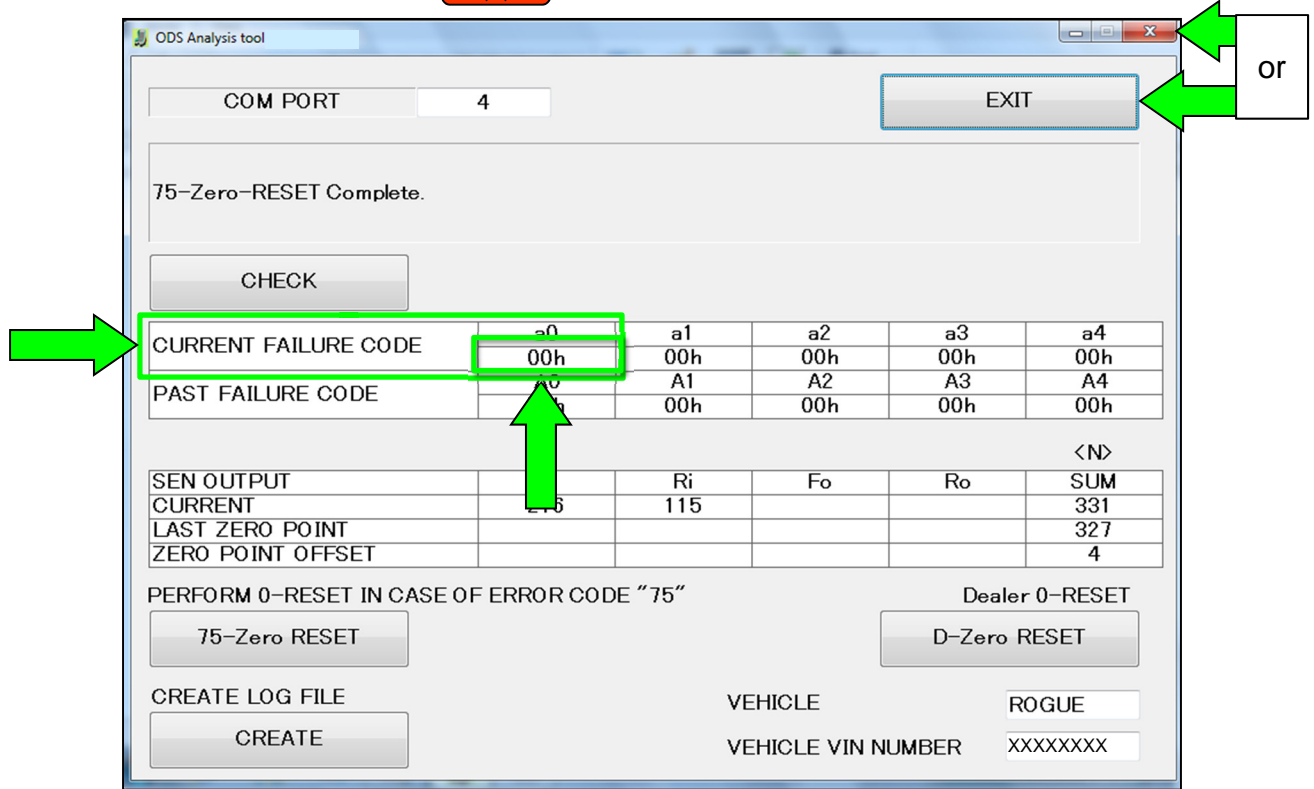
17. When the screen in Figure 10 displays, the 75-Zero reset process is complete.
 - Verify code “75h” is not displayed under **CURRENT FAILURE CODE**.
18. Select either **EXIT** or the
