Service Bulletin

Bulletin No.: 21-NA-120

Subject: Diagnostic Tip for Noise, Vibration and/or Harshness Issues/Clunk Noise Heard During Coast Down Event

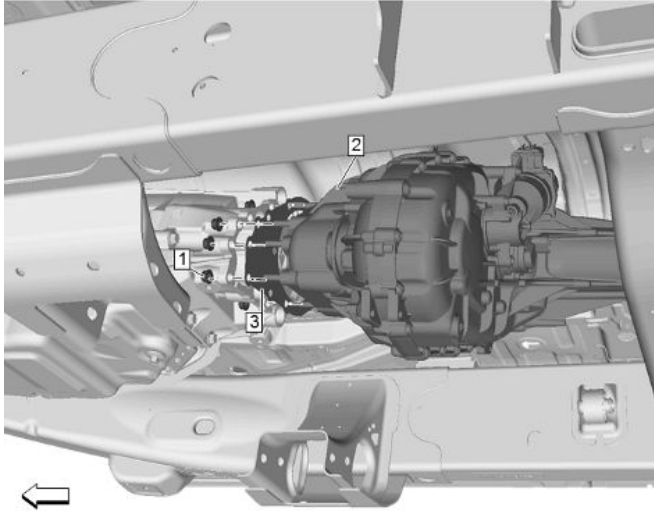
Involved Region or Country	North America, Middle East, Israel
Additional Options (RPOs)	NQF (TRANSFER CASE-ELECTRIC SHIFT CONT, TWO SPEED, ALUM) NQH (TRANSFER CASE-ACTIVE, TWO SPEED, SWITCH ACTIVATED, ALUM)
Condition	Some technicians or customers may comment on one or more of the following conditions after the transfer case was removed from the transmission and reinstalled during a recent repair: <ul style="list-style-type: none"> • Harsh downshift during a coast down event • Noise during a coast down event • Vibration during a coast down event • Harshness issues such as a clunk noise heard during coast down event
Cause	This condition may be caused by a misalignment between the transmission output shaft and the transfer case input. ⇒ Transfer case to transmission misalignment could cause the transfer case shift collar to slip out of engagement.

</div> <p style="text-align: right; font-size: small;">5411622</p> <ol style="list-style-type: none"> 1. Connect the GDS Scan Tool and monitor transmission shift data. 2. Drive the vehicle and duplicate the condition while monitoring transmission shift data to determine if the noise/clunk/roughness occurs during the downshift or if the noise/clunk/roughness occurs randomly during the de-acceleration event. <p>⇒ If it is determined that the noise/clunk/roughness does not occur at a transmission downshift, shift point follow published Service Information for Transfer Case Assembly Replacement (with MGM, MGU, MKM Automatic Transmission).</p> <p>Note: The transfer case does not need to be completely removed from the vehicle. The attaching bolts must be loosened (not removed) to allow the transfer case to be separated from the transmission a minimum of a ½ (13mm) but no more than 1 inch (25mm). The use of transmission jack or adjustable jack stand may provide support in holding the transfer case to the transmission. Proper transfer case to transmission bolt installation, tightening sequence and proper torque must be followed.</p> <p>If the noise/clunk/roughness is occurring during a transmission downshift, shift point, refer to SI for further diagnostics.</p>
