**Subject: Loss of Steering Assist and/or Loss of Brake Assist Malfunction Indicator Lamp (MIL) Illuminated - DTCs P25A2, U0422, C1595, U0420, C116C, B3205, B127B and/or B1325 Set**

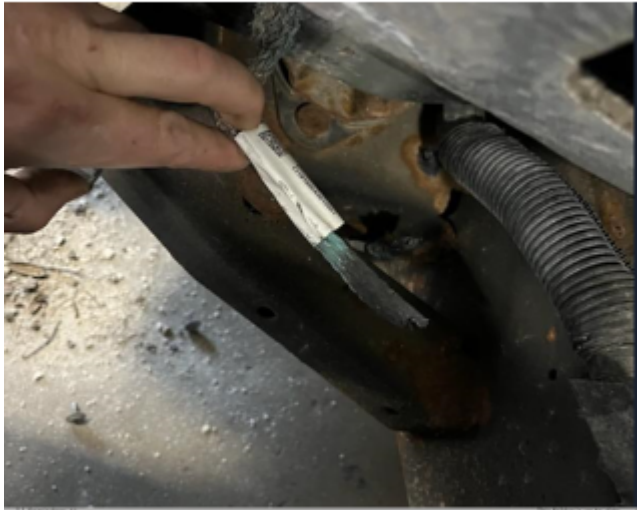
6483337

This condition may be caused by High resistance in the G132 and G133 grounds, located behind the RH wheelhouse liner.
