Soft Top Opening or Closing Function Impaired

| Topic number | LI77.30-P-078299 |
| Function group | 77.30 - Vario roof, soft top - complete |
| Validity | Model designation 236.4xx |

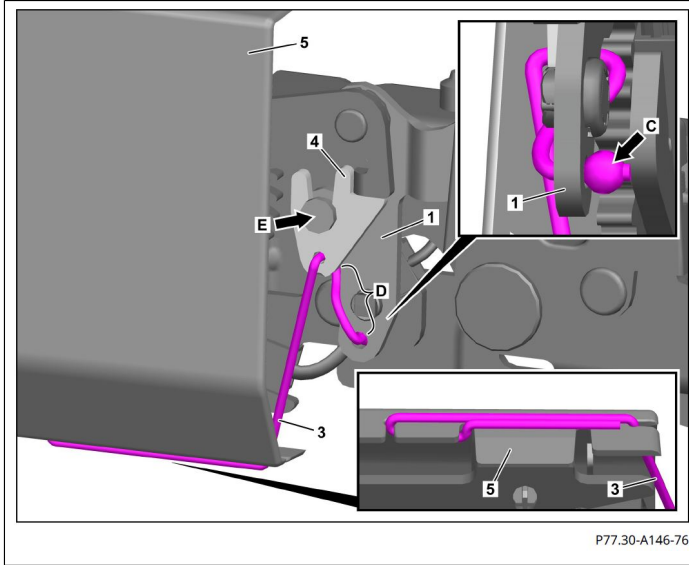
| Attachments | |
|---|---|
| <a href="#">Cordel_1.JPG</a> | |

For a problem involving the soft top opening/closing function in combination with the cited fault code, the retainer lock (4) on the closure of the soft top compartment cover may no longer be seated in its position.

The control cable may have become detached from its tray and pulled off the retainer lock as a result

Cut through control cable (3) at knot (C) and remove from vehicle. Then install retainer lock (4) again in the position described in WIS.
