Windshield Washer Fluid System Leaks - General Diagnosis

Topic number	LI82.35-P-078467
Version	1
Function group	82.35 - Windshield washing system
Date	10/22/24
Validity	All passenger car model series
Reason for change

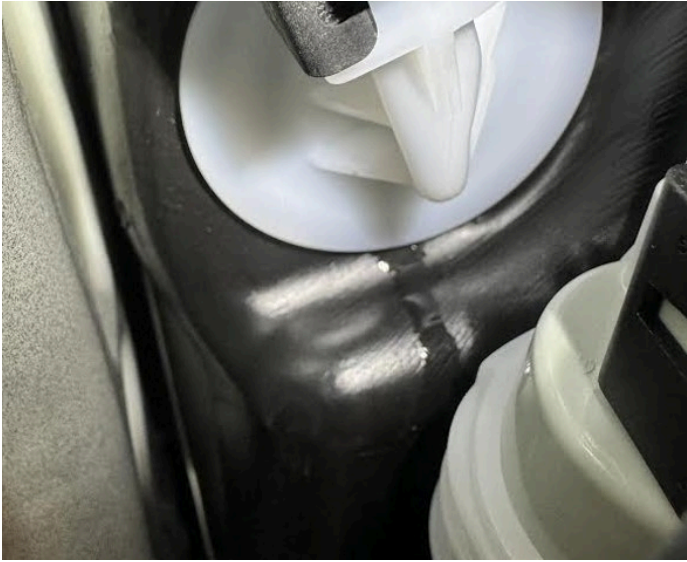
Attachments	
File	Description
Bild1.1.jpg	Leakage on sensor

Replace defective component parts only. Do not replace any adjacent component parts that are intact.

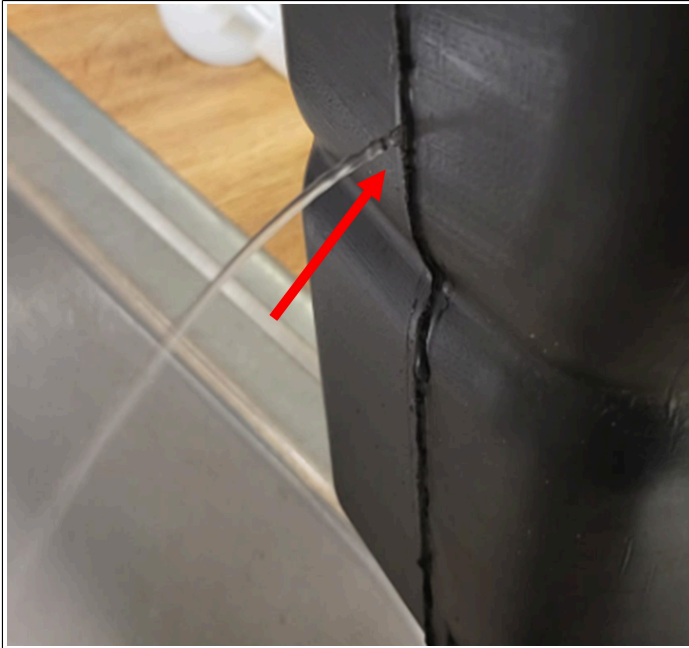
Bild1.2.jpg	Leakage on seam

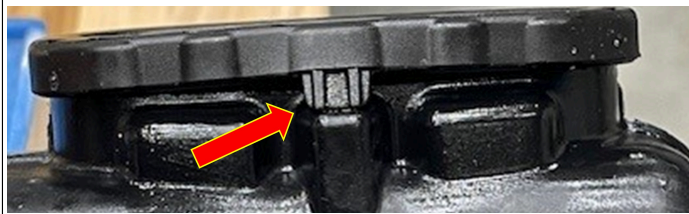
Bild1.3.jpg

Leakage on cap

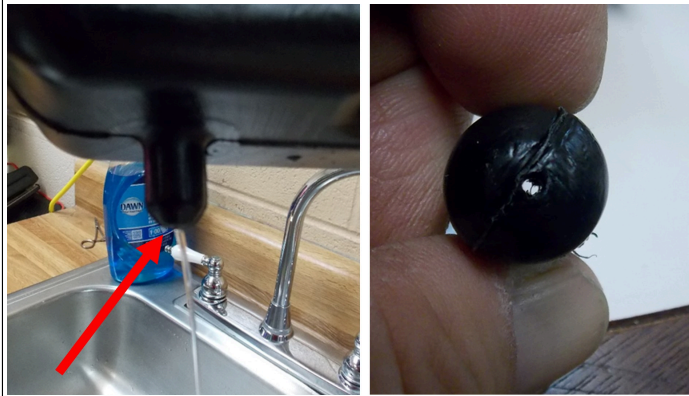
Bild1.4.jpg

Leakage on lower container

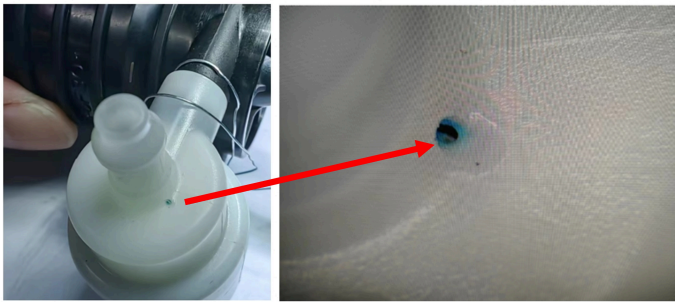
Bild3.1.1.jpg

Leakage on washer fluid pump housing

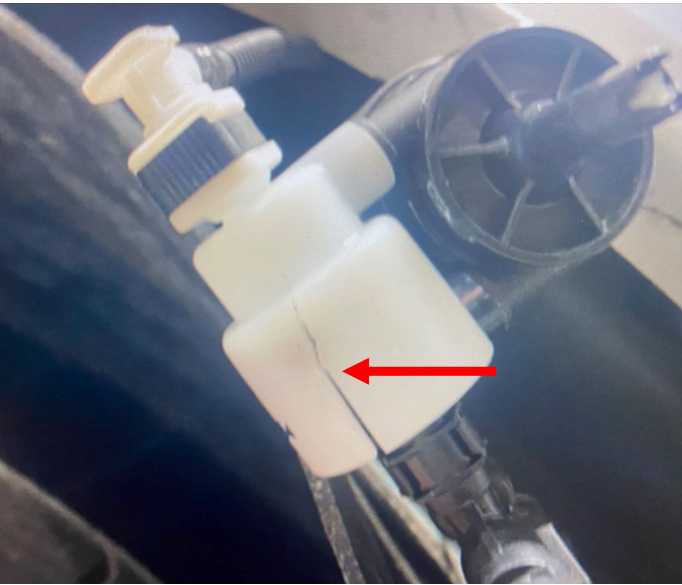
Bild3.1.2.jpg

Leakage caused by cracked washer fluid pump distributor housing

1. Washer fluid reservoir itself.
2. Seal on washer fluid pump/washer fluid reservoir.
3. Washer fluid pump.
 - 3.1. Distributor housing leaks.

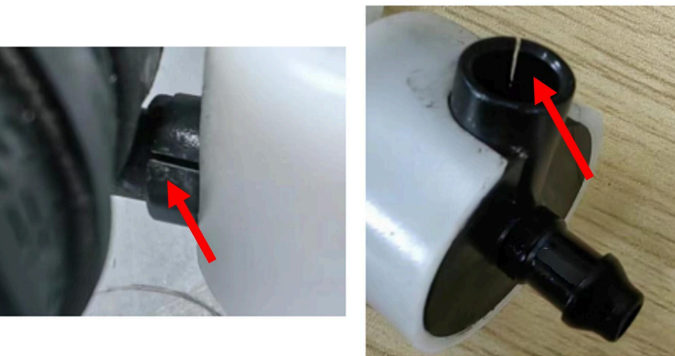
Bild3.1.3.jpg

Leakage caused by cracked washer fluid pump fitting

- 3.2. Pump fitting leaks.
- 3.3. Washer fluid hose cannot be snapped into place on pump fitting.
- 3.4. Washer fluid hose will not stay on pump fitting, although connector OK.

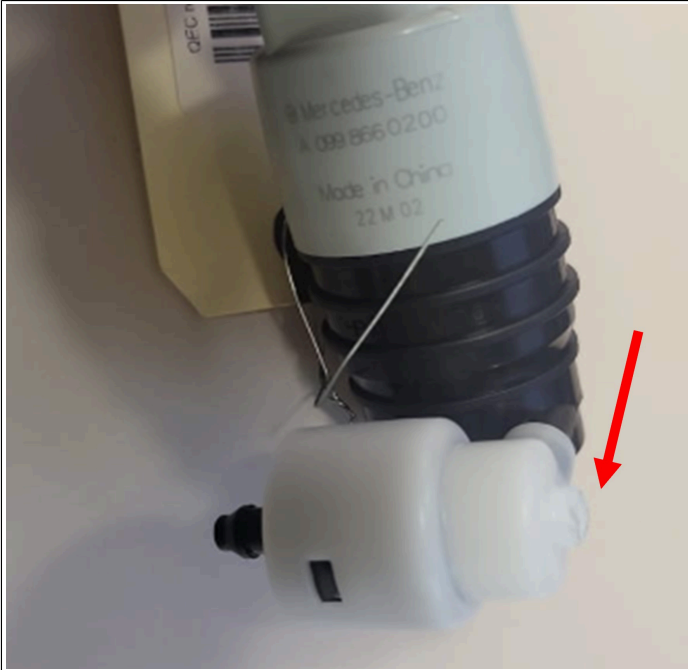
Bild4.1.jpg

Broken washer fluid pump fitting

- 4. Washer fluid line.
 - 4.1 Connector will not stay on pump fitting because it is broken.
 - 4.2 Sealing ring in connector missing.
 - 4.3 Sealing ring in connector fitted, but deformed and therefore leaks.
 - 4.4 Damage to washer line by animal.

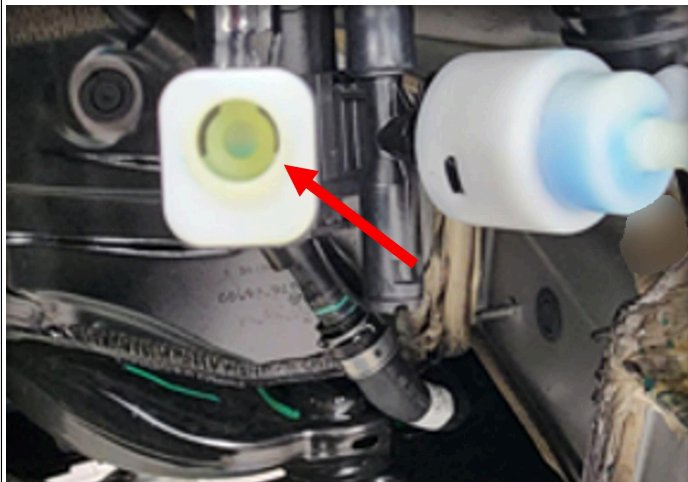
Bild4.2.jpg

O-ring for washer fluid line missing

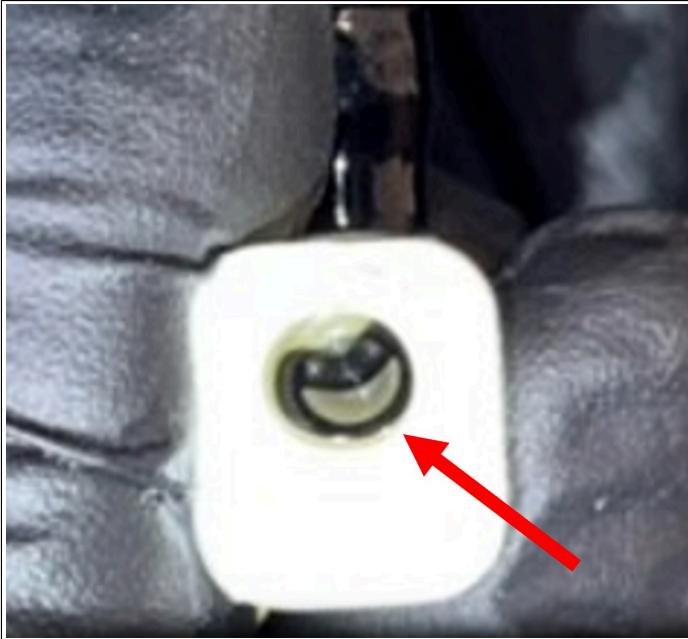
Bild4.3.jpg

O-ring for washer fluid line deformed

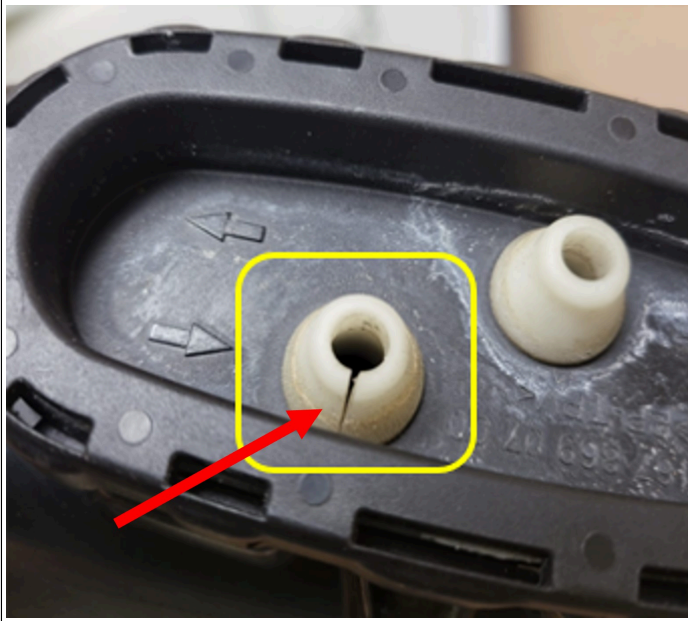
Bild5.jpg

Seal for washer fluid heater lines cracked

- 5. Seal on heating washer fluid reservoir/washer fluid reservoir.
