# Service Bulletin

Bulletin No.: 24-NA-027

**Subject: DTC U3000 Setting in Automated Map Module (HDLM) – Super Cruise Unavailable**

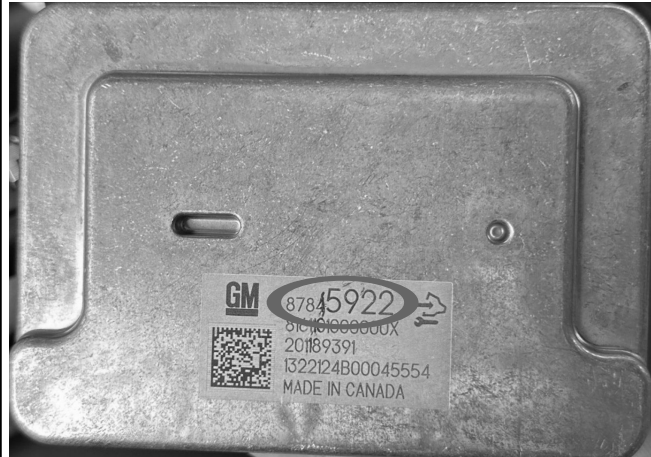
If one of these Map module part numbers listed in Parts Information is not installed in the vehicle, and the map module is setting the U3000 DTC with Super Cruise being unavailable, do not replace the module until additional diagnostics through SI are completed. 6553204

| <b>Correction</b> | Technicians are asked to verify the condition by driving on 2 different verified Super Cruise roads. Replace the HDLM module if, and only if, the part number of the HDLM in the vehicle is listed in Parts Information.<br><b>Important:</b> Please refer to the Electronic Parts Catalog (EPC) to order the latest release part number for this module. |
