Service Bulletin

Bulletin No.: 24-NA-088

Subject: Diagnostic Tip for Malfunction Indicator Lamp (MIL) Illuminated, Transmission Not Shifting/Default Mode - DTC P0747 Set

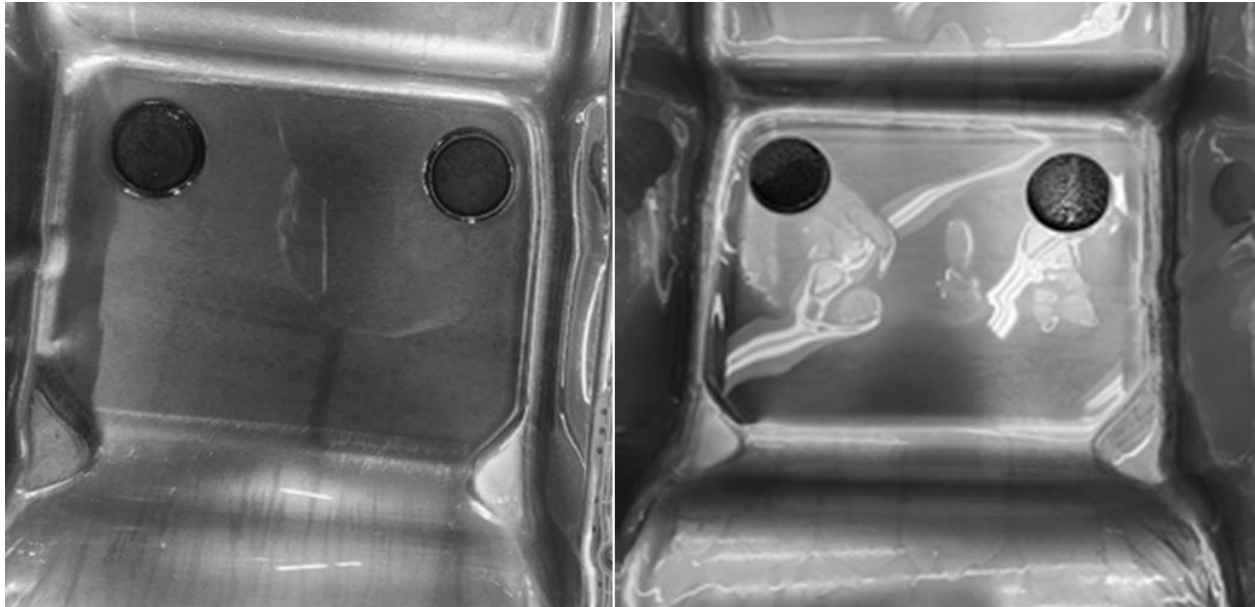
6639318

The fluid in the graphic above shows good color with no evidence of clutch material. This unit should be serviced with a valve body.

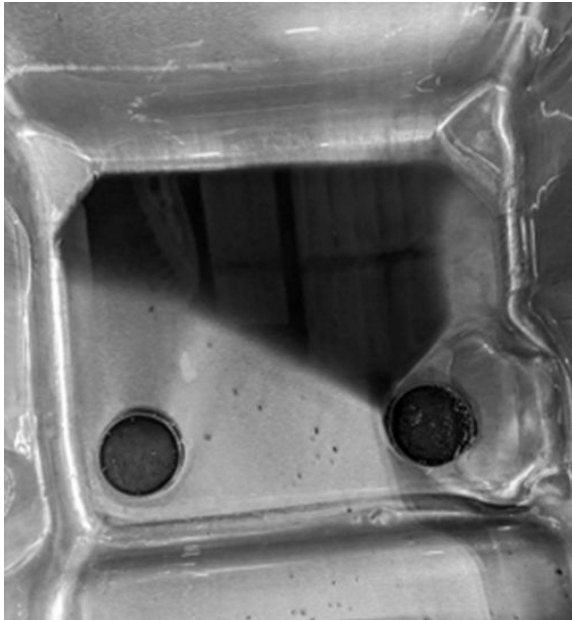
6639319

The fluid in the graphic above shows dark color with minimal evidence of clutch material. This unit did not exhibit a burnt odor. This unit should be serviced with a valve body.

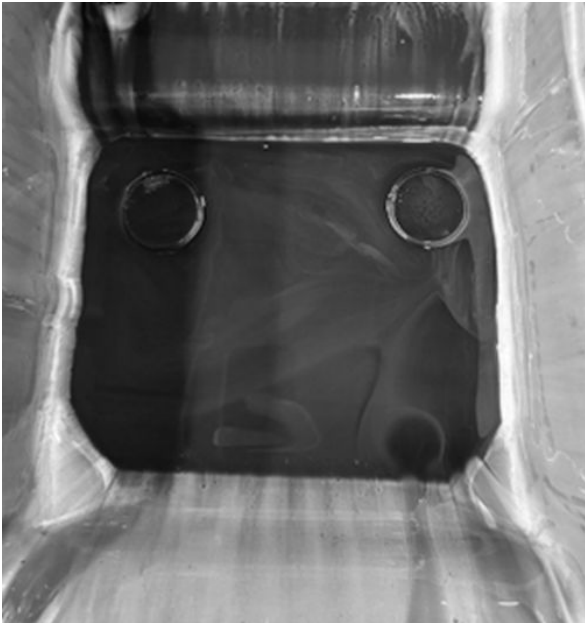
6639320

The fluid in the graphic above shows extreme distress and clutch material is starting to appear in the pan. This unit should be removed from the vehicle and disassembled for inspection to determine what clutches have been damaged. Any suspect clutch should be repaired following published Service Information (SI), or the unit replaced following Policy and Procedure Cost vs Replace guidelines. The control valve body should be replaced as well.
