Flush-Mounted Door Handle Jams When It Is Pulled Out

Topic number	LI72.10-P-074316
Version	4
Function group	72.10 - Front door
Date	10/22/24
Validity	MODEL 214 with CODE 889 MODEL 223 with CODE 889 MODEL 232 with CODE 889 MODEL 294 with CODE 889 MODEL 295 with CODE 889 MODEL 296 with CODE 889 MODEL 297 with CODE 889
Reason for change	Validity adapted

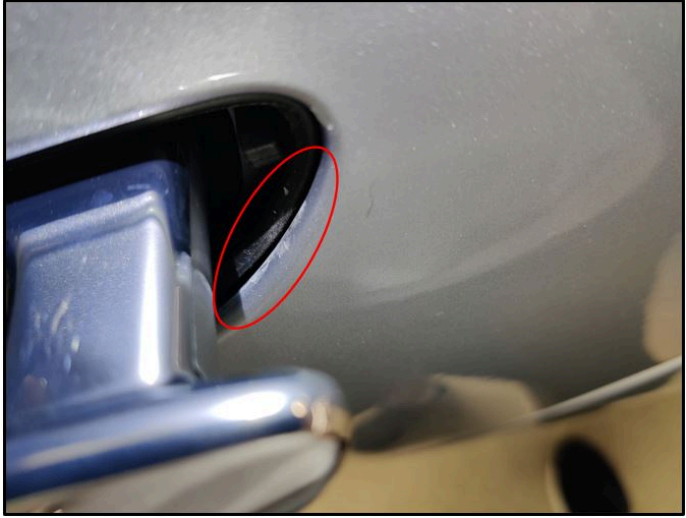
Attachments	
File	Description
Bild 1.JPG	Figure 1

- The flush-mounted door handle could jam when it is pulled out and may move in a jerky manner when doing so.
- In the area of the paneling section of the door, paint damage could be present (picture 1) and/or an abrasion point could be present at the door handle (picture 2).

3.) Paint over paint damage at door paneling (see picture 1) according to manufacturer specifications, using spot repair procedure if necessary.

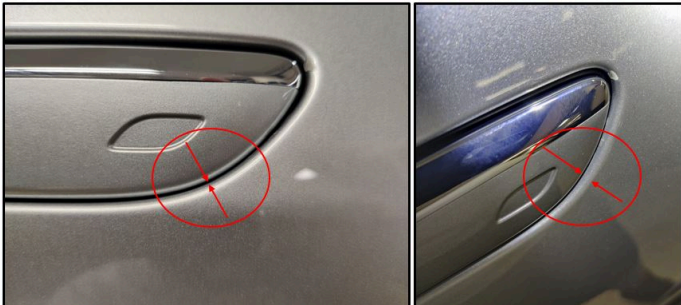
File	Description
Bild 3.JPG	Picture 3

The door handle could be installed too low in the y direction and/or the z direction (picture 3); as a result, the door handle could brush the door at the paneling section of the door.
