<b>Release Date</b>	09/04/2024	<b>Technical Service Bulletin</b>	
<b>91VT UPDATE</b>

<b>Audi</b>
<b>Customer Satisfaction Package – (NVLW)</b>

## Condition/Technical Background

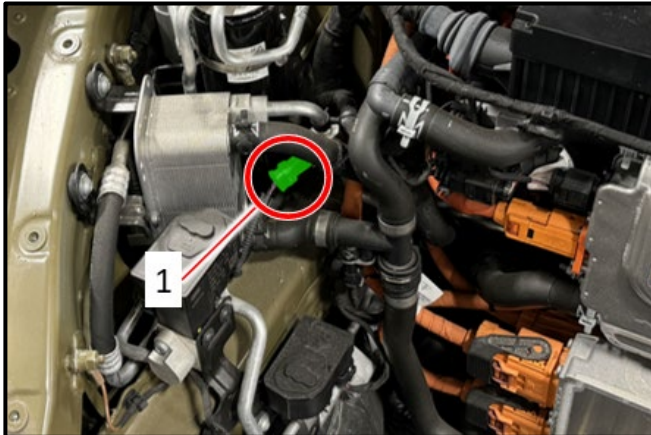
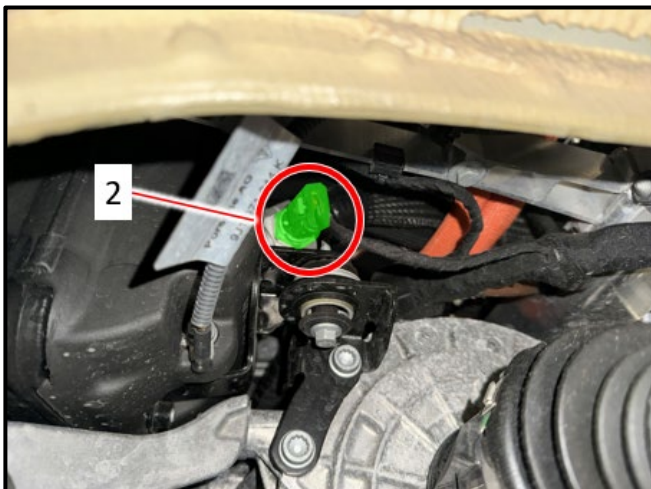
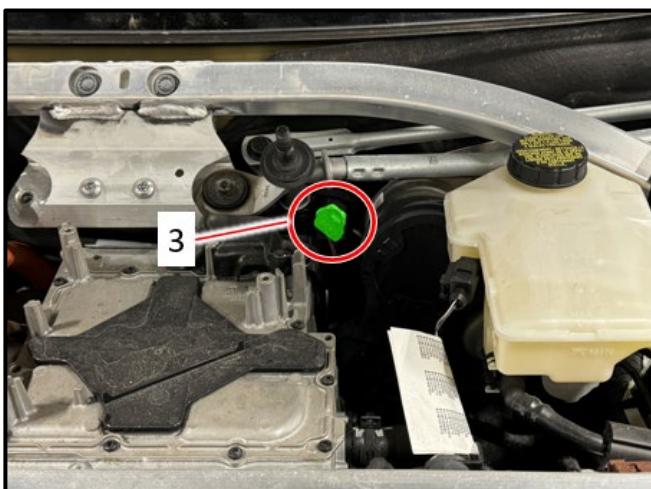
## Section B – Inspect Refrigerant Pressure/Temperature Sensors (criteria K1)

The refrigerant pressure/temperature sensors do not require removal for inspection. **Do not** recover the refrigerant charge during the inspection section.

- Access, but do not remove, the G395, G826, and G827 refrigerant pressure/temperature sensors per the ELSA repair manual:
  - **G395 sensor <1>**: *Repair manual > Heating, Ventilation & Air Conditioning > Heating, Ventilation and Air Conditioning > 87 Air Conditioning > Refrigerant Circuit > A/C Pressure/Temperature Sensor G395, Removing and Installing.*
  - **G826 sensor <2>**: *Repair manual > Heating, Ventilation & Air Conditioning > Heating, Ventilation and Air Conditioning > 87 Air Conditioning > Refrigerant Circuit > A/C Pressure/Temperature Sensor 2 G826, Removing and Installing.*
  - **G827 sensor <3>**: *Repair manual > Heating, Ventilation & Air Conditioning > Heating, Ventilation and Air Conditioning > 87 Air Conditioning > Refrigerant Circuit > A/C Pressure/Temperature Sensor 3 G827, Removing and Installing.*

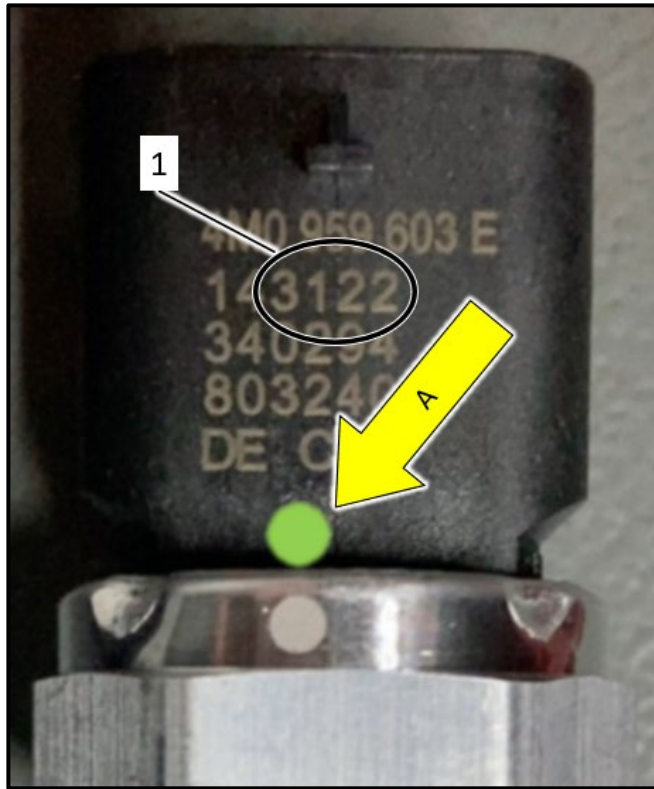
- Check for a green dot <arrow A> on the G395, G826, and G827.
- If the green dot is present on **all three** sensors:
  - The sensors do not require replacement.
  - Continue with the reassembly instructions in this section.
- If the green dot is **NOT** present on the sensors:
  - Check the production date <1> of the sensor.
  - If the sensor was produced on or before calendar week 31 of 2021, the sensor requires replacement.

The production date <1> of the sensor pictured is calendar week 31 of 2022. This sensor does not require replacement. The date format is week/year.

- If a sensor requires replacement:
  - **Proceed to section C.**
- If **all three** sensors are ok and do not require replacement:
  - Continue with the reassembly instructions in this section.
