# Technical Service Bulletin

## 40 Rumbling noises from the suspension - upper link rubber mounting

40 24 81 2060855/2 September 10, 2024. Supersedes Technical Service Bulletin Group 40 number 20-14 dated October 7, 2020 for reasons listed below.

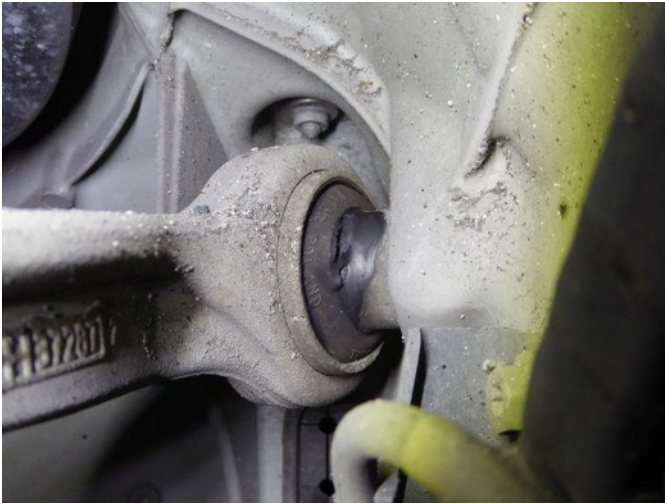
- Rumbling noises from the suspension.
- Damage on the rubber mounting of the upper link can be identified (Figure 1).

*Figure 1. Damage to the rubber mounting.*

This complaint can be caused by frequent maneuvering.

Replace the damaged rubber mounting of the upper rear link (Figure 2) on both sides of the vehicle according to the Elsa repair manual: *Chassis >> Suspension, Wheels, Steering >> 40 Front Suspension >> Suspension Strut and Upper Control Arm >> Upper Control Arm Bearing Replacing.*
