Technical Service Bulletin

40 Noises from front end of vehicle when steering and/or when suspension compresses

40 24 83 2075251/1 September 17, 2024.

Model(s)	Year	VIN Range	Vehicle-Specific Equipment
Q4 e-tron, and Q4 Sportback e-tron	2022 – 2025	All	Not Applicable

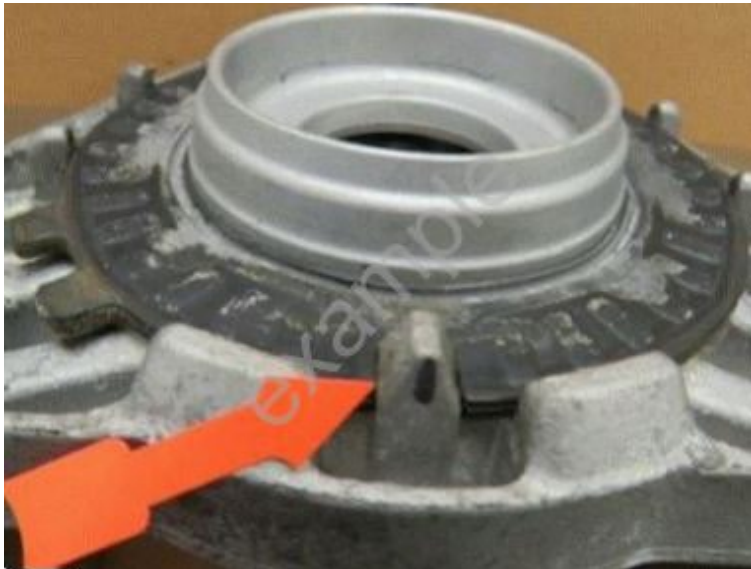
Under unfavorable conditions (overlapping of component tolerances), contact may occur between the positioning lug on the suspension strut mounting and the deep groove ball thrust bearing. This can cause a noise during steering and/or when driving over bumps (when the suspension compresses).

Figure 1. Positioning lug on suspension strut mounting.

- File down/shorten positioning lug on suspension strut mounting (see Figure 1, red arrow) by approx. 3 mm using suitable workshop tools (e.g. a metal file).

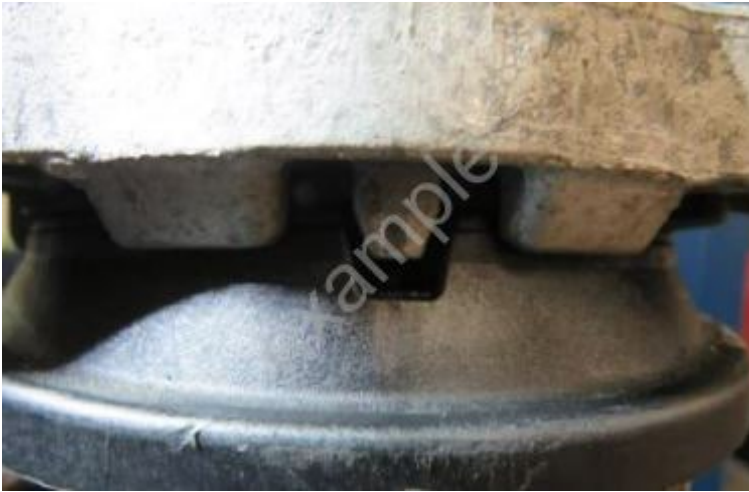
Figure 2. Example: sufficient clearance between suspension strut mounting and deep groove ball thrust bearing.

- Reassemble suspension strut mounting and deep groove ball thrust bearing and check that there is sufficient clearance (see Figure 2):
- If there is sufficient clearance, continue with the next step.
- If there is insufficient clearance, file down/shorten positioning lug on suspension strut mounting further as required. Then continue with the next step.
