Technical Service Bulletin

42 Noises from shock absorbers/shock absorber mountings on the rear axle

42 24 57 2064019/4 September 6, 2024. Supersedes Technical Service Bulletin Group 42 number 23-51 dated March 27, 2023 for reasons listed below.

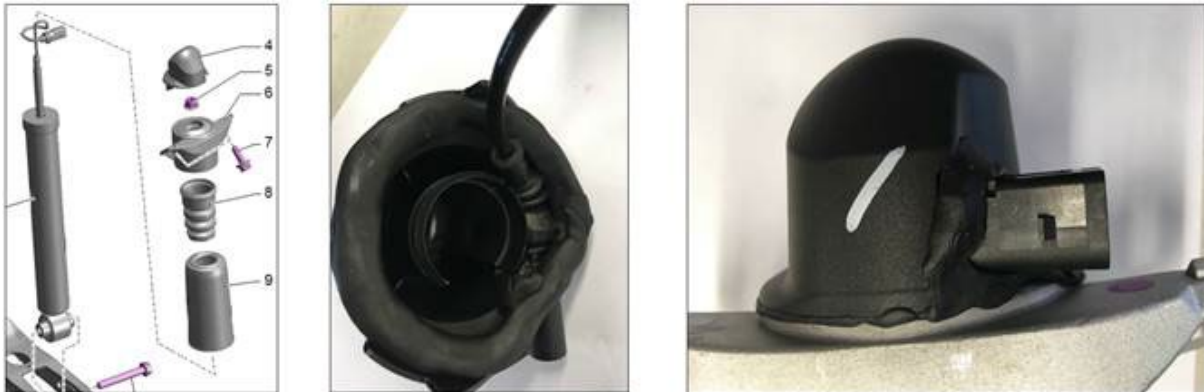
- The noises come from the area of the rear shock absorbers/from the shock absorber mountings. Please bear in mind that the complaint described depends on the temperature, as it is caused by ice or frozen dirt above the shock absorber mounting. You can check whether the customer complaint is due to the described cause by carefully heating up the shock absorber mounting.

At temperatures below 32 °F, frozen water/dirt above the shock absorber mountings causes restrictions to the operation of the shock absorber mounting.

Figure 1. Example of Butyl sealing cord application and component location.

1. Remove both rear shock absorbers according to Elsa at Repair Manual, *Chassis >> Suspension, Steering, Wheels >> 42 Rear Suspension >> Suspension Strut, Shock Absorber, Spring.*
2. Replace the shock absorber mountings on both sides (Figure 1, picture 1 with item 6).

3. Install the new mountings, use approx. 10 in of butyl sealing cord on each side of the vehicle to make a seal between the protective cap (Figure 1, picture 1 with item 4) and shock absorber mounting (Figure 1, picture 1 with item 6) (Figure 1, picture 2 and 3).
4. Before working with the butyl sealing cord, make sure that the sealing surfaces of the new shock absorber mounting, and the corresponding shock-absorber protective cap are clean and dry. The shock absorber cap (item 4) can be re-used.
