Technical Service Bulletin

45 MIL on - DTC P258B00 or P055600

45 24 48 2072305/2 September 10, 2024. Supersedes Technical Service Bulletin Group 45 number 23-35 dated December 13, 2023 for reasons listed below.

Model(s)	Year	VIN Range	Vehicle-Specific Equipment
Q3	2021 – 2025	All	Not Applicable

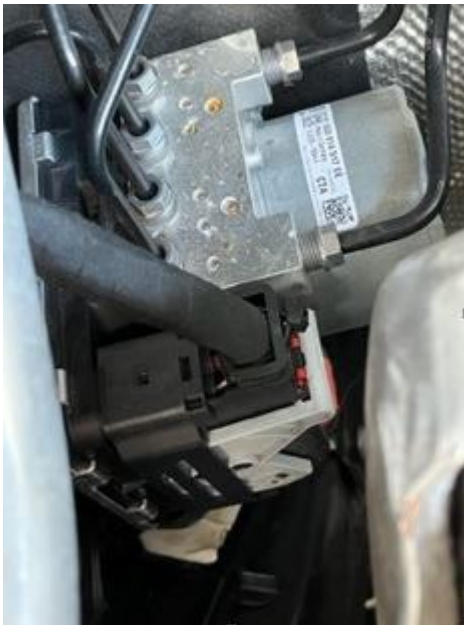
The analyses have shown that the vacuum pump fuse was blown due to the connector of the ABS control unit being improperly disconnected. The improper separation of the ABS connector and the subsequent running of the engine / driving operations meant that the vacuum pump exceeded certain internal parameters. As a result, the vacuum pump fuse blows and the vacuum pump itself can become irreparably damaged / can fail.

Figure 1: ABS hydraulic unit / ABS control unit connector.

- Take pictures of the ABS control unit/ABS control unit connector and upload to DOC-IT.
- Check if the connector has been unplugged from the ABS control unit, or if there are any signs of tampering (e.g., scratches on the connector).
- If the connector has been unplugged from the ABS control unit or if tampering has been determined, the repair cannot be billed under warranty.
- Replace triggered / blown vacuum pump fuses according to *ELSA>>Repair Manual>>Electrical System>>Electrical Equipment>>97 Wiring>>Relay Panels, Fuse Panels and E-Box>>Component Location Overview*.
- Check if the vacuum pump works and runs properly as per *ELSA>>Repair Manual>>Chassis>>Brake System>>47 Hydraulic Components>>Vacuum System>>Overview Vacuum Pump*.

- If the connector has been unplugged from the ABS control unit or if tampering has been determined, the repair cannot be billed under warranty.
- If the connector has not been unplugged from the ABS control unit and no tampering has been determined, this TSB does not apply!
