Technical Service Bulletin

48 Vehicle cannot be started (DTC P160A00); Steering column can be pushed in too far

48 24 71 2073237/2 September 10, 2024. Supersedes Technical Service Bulletin Group 48 number 24-63 dated March 5, 2024 for reasons listed below.

| Model(s) | Year | VIN Range | Vehicle-Specific Equipment |
|---|---|---|---|
| Q3 | 2019 – 2025 | All | Not Applicable |

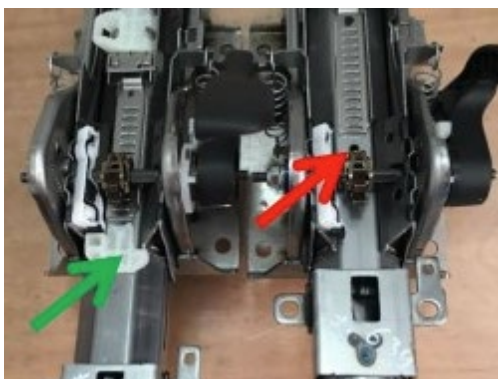
- The customer statement can be reproduced.
- Regarding to 1) The DTC **P160A00 Control Module Faulty** has been logged in the electronic steering column lock (diagnostic address 002B).
- Regarding to 2) The longitudinal stop on the steering column is damaged/missing (Figure 1).

Figure 1. Steering column on left is OK (the longitudinal stop is installed); steering column on right is not OK (the longitudinal stop is missing).

- When adjusting the steering column, excessive force was applied to the longitudinal stop, damaging it.
- It is not possible to modify/optimize the longitudinal stop as it must comply with the required safety standards.
- The procedure for checking the steering column is described in the Workshop annual.
- If the longitudinal stop is missing, it may no longer be possible to engage or release the electronic steering column lock under unfavorable circumstances.
- If the electronic steering column lock does not reach its end stops, it no longer approves the terminal release, and the ignition cannot be switched on.

Please explain to the customer that excessive force should not be applied when adjusting the steering column.
