# Technical Service Bulletin

## PSS 91 MIB3: "Loading system. Please wait..." displayed after driving for an extended period

91 24 57 2075325/1 September 18, 2024.

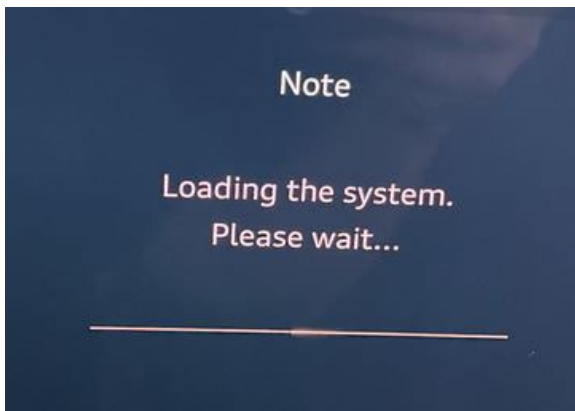
"Loading system. Please wait..." (see Figure 1).

Figure 1: MMI message.

- When this message appears, the MMI system can no longer be operated via the display.
- The MMI system continues to run in the background and audio is output.
- The system can be operated using the multifunction steering wheel controls.

Software issue on the control unit one for information electronics -J794- (address word 005F)

Restart the MMI:

- Press and hold the on/off button for at least 10 seconds.
- The MMI screen goes dark temporarily and the MMI restarts.
- The system can then be operated normally again.
- However, the complaint can reoccur.
