# Technical Service Bulletin

## 93: High-Voltage fault, gearbox fault or MIL on in the instrument cluster DTC(s) P0A4000, P0A2E00 or P0A2B00

93 24 14 2066596/3 September 18, 2024. Supersedes Technical Service Bulletin Group 93 number 24-00 dated July 31, 2024 for reasons listed below.

Model(s)	Year	VIN Range	Vehicle-Specific Equipment
A7 e quattro	2021 – 2022	All	Not Applicable

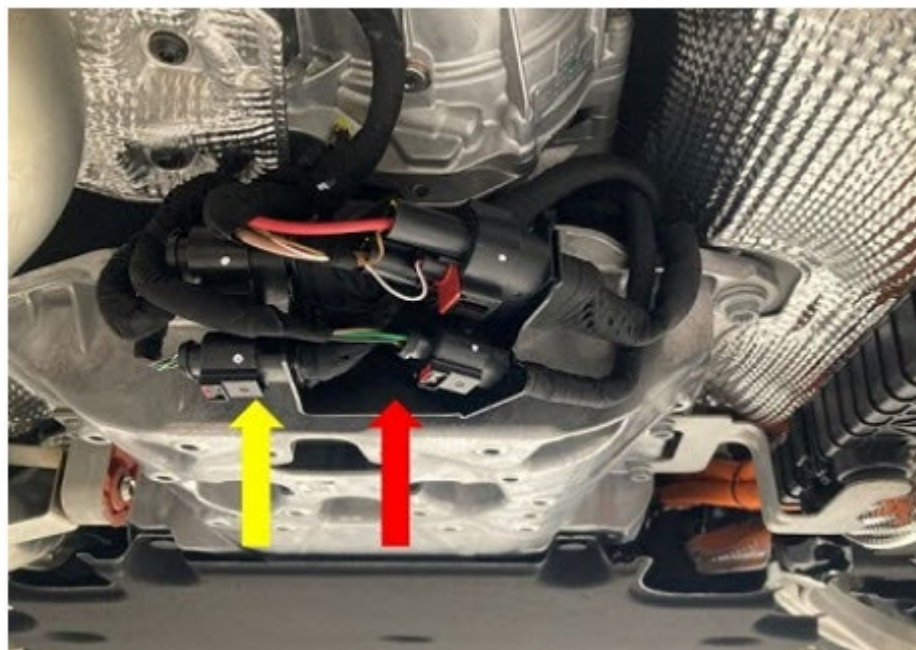
**Figure 1.** Connector locations.

Contact abrasion in connector T6bm / T6bmx.

1. Replace the connector housing bracket installed in the vehicle with the new bracket 8W0.971.502.AL (Figure 1 red arrow).
2. Replace the connector at the coupling point T6bm/T6bmx with 3B0.973.813 and 4H0.973.713.G (Figure 1 yellow arrow).
3. Replace all the pins in the new connector and mating connector with gold-plated pins using the wiring harness set VAS 1978B/C.
4. For modified connector 3B0.973.813, use single wires 000.979.041.EA and for connector 4H0.973.713.G use single wires 000.979.025.EA.
