GENERAL MOTORS DCS7060 URGENT - DISTRIBUTE IMMEDIATELY

- Subject: REVISION: N242435631-05 Customer Satisfaction Program Serial Data Gateway Module Revised Service Procedure and Warranty Information
- Models: 2022 2024 Chevrolet Silverado 1500 2024 Chevrolet Silverado 2500HD/3500HD 2022 - 2024 Chevrolet Suburban 2022 - 2024 Chevrolet Tahoe 2022 - 2024 GMC Sierra 1500 2024 GMC Sierra 2500HD/3500HD 2022 - 2024 GMC Yukon / Yukon XL

N242435631 Serial Data Gateway Module

Revision: 05

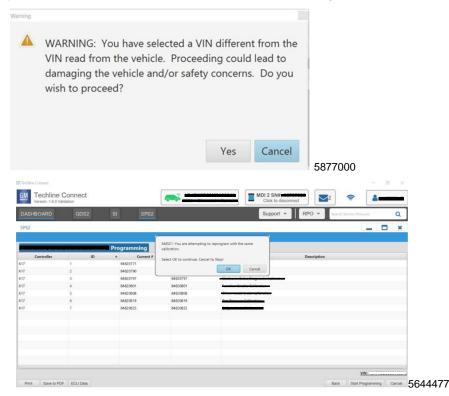
Important: If the vehicle VIN DOES NOT match, the message below will be shown.

Caution: Be sure the VIN selected in the drop down menu (1) is the same as the vehicle connected (2) before beginning programming.
