HYUNDAI Technical Service Bulletin

GROUP ENGINE	NUMBER 24-EM-008H
DATE OCTOBER 2024	MODEL(S) VENUE (QX)

SUBJECT: ECU UPDATE – DTC P250F OIL LEVEL SENSOR WARNING LIGHT LOGIC

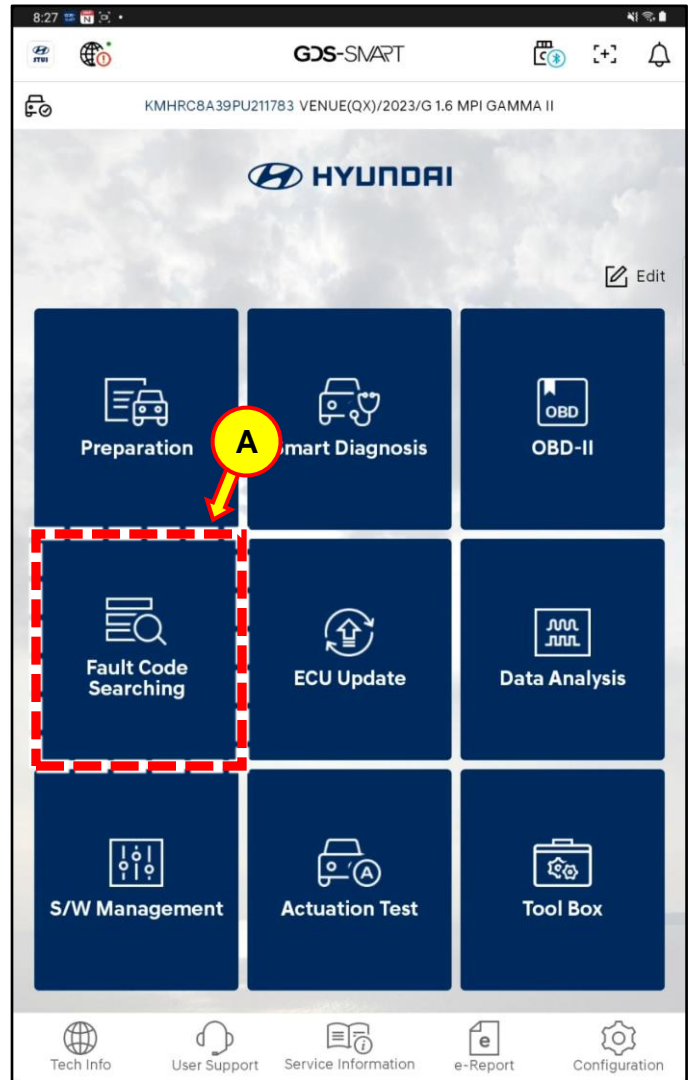
1. Connect the GDS.
2. Turn **ON** the IGN Switch.
3. Select **Fault Code Searching (A)** on the GDS-Smart home screen.

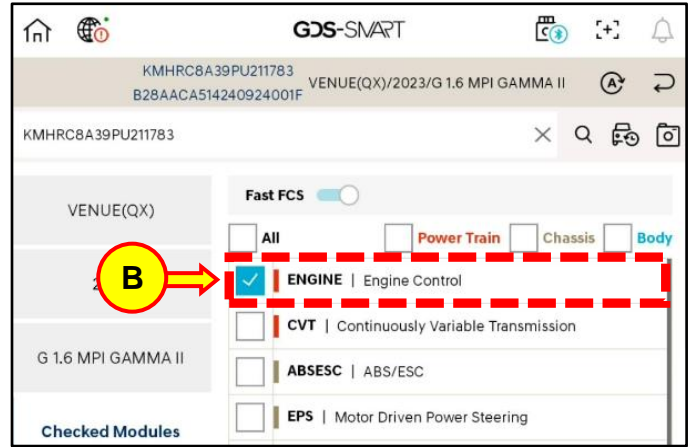
4. Select **ENGINE (B)** and press **OK**.

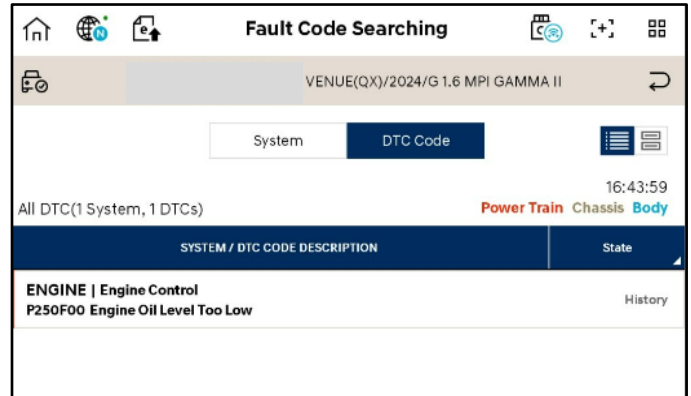
5. If **DTC P250F** is found, continue to check the engine oil level in **Step 6** prior to performing the ECU update.

- If any other DTC is found, this TSB does **NOT** apply. Follow the DTC Guide to appropriately diagnose and repair the vehicle.

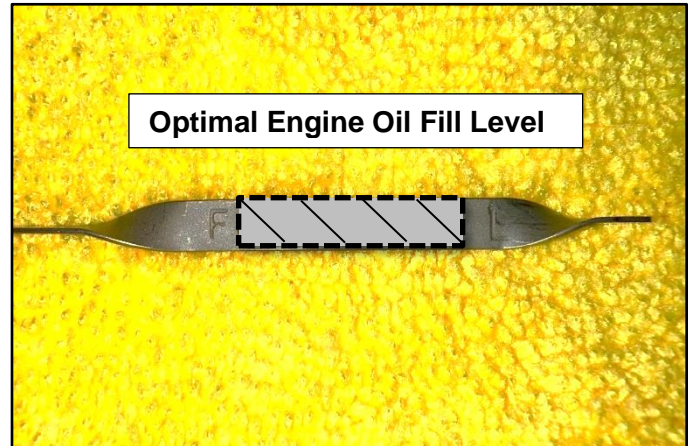
6. Inspect the engine oil level using the vehicle's engine oil dipstick.

- If the oil level is between the low ('L') and full ('F') line (optimal engine oil fill level), then proceed to the **ECU Update Procedure** to perform the ECU logic update.
- If the oil level is below the low ('L') line, then **DO NOT** proceed with the ECU logic update. Follow normal diagnostic procedures to diagnose the low oil level condition.

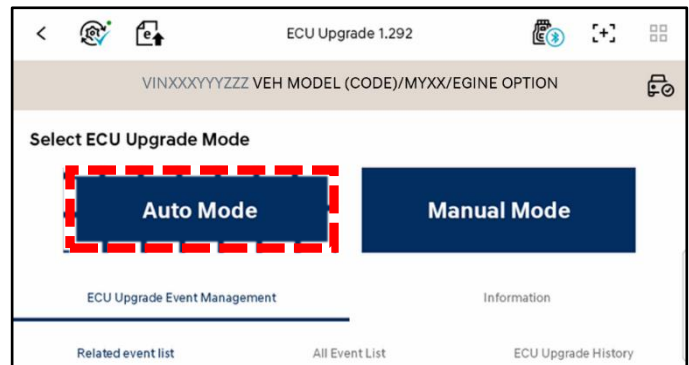
1. Perform the ECU update in **Auto Mode**.

Use the **ID Check** to verify the ROM ID before updating the software.

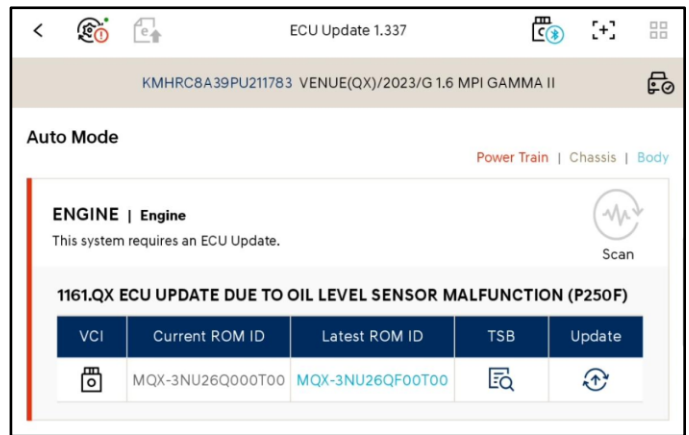
2. Select the **ENGINE** system to scan the vehicle's current ROM ID.

Check the current ROM ID version and compare it to the ROM ID Information table before attempting to perform the software update.

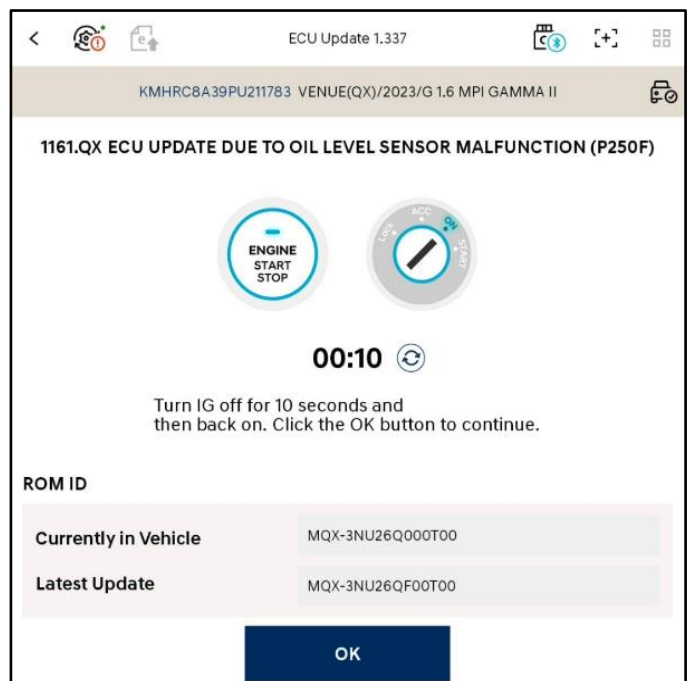
3. After the ECU update process shows 100% complete, follow the prompts on the screen to cycle the ignition **OFF** for at least **10 seconds** to reset the control unit (certain models may take up to **30 seconds**).

Use the **Refresh** button to reset the timer.

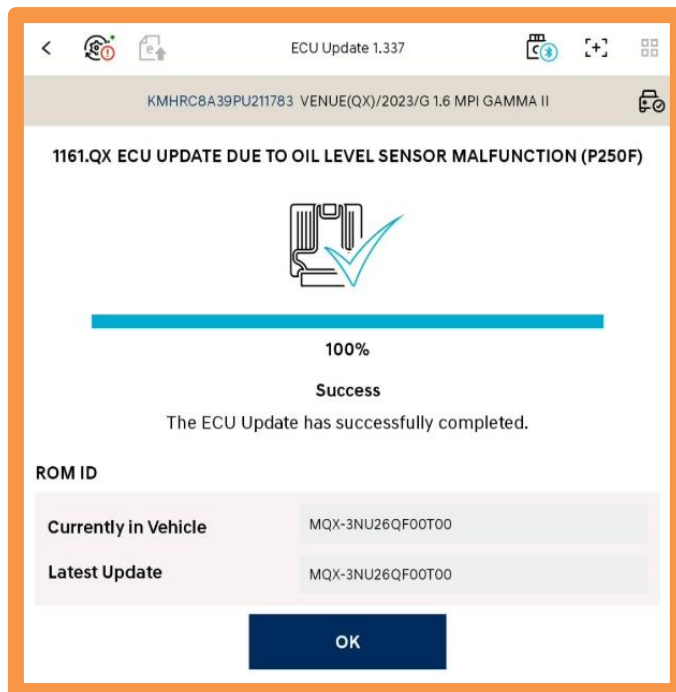
Take a screenshot of the ECU update complete screen using your tablet and upload to STUI.
