Technical Service Bulletin

GROUP**CAMPAIGN****NUMBER****24-01-074G****DATE****OCTOBER 2024****MODEL(S)****SEE BELOW****SUBJECT:**

OUTER DOOR HANDLE TOUCH SENSOR REPAIR
(SERVICE CAMPAIGN T58G)

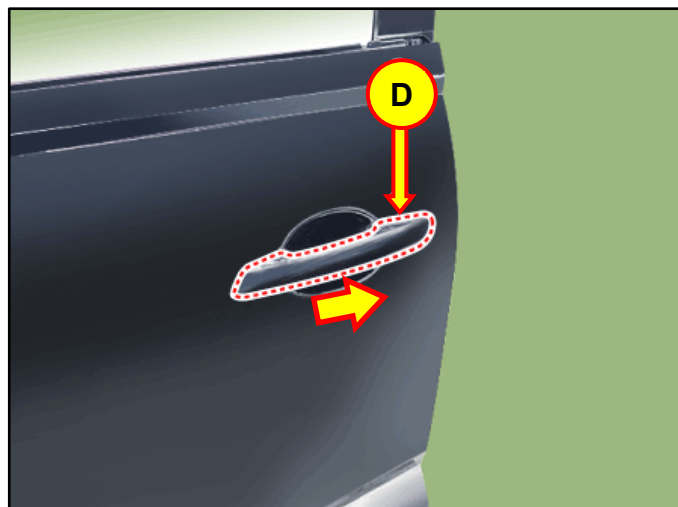
If the female connector is not fully secured, it may fall inside the door panel. If this occurs, the door trim panel and module will need to be removed to access the connector from inside the door panel.

5. Secure the female connector (E) onto the indicated hook (F), then disconnect the male connector (G).

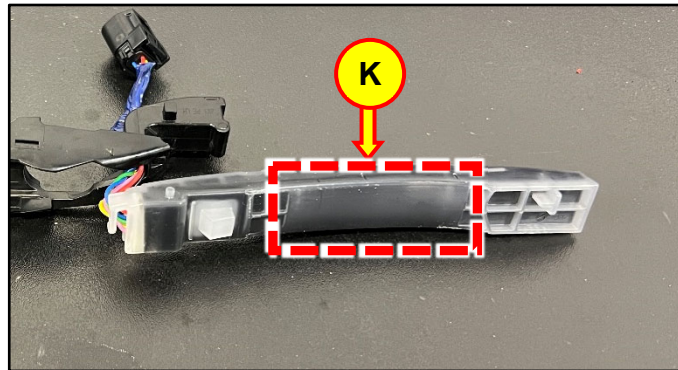
Description: Certain 2025MY G80 (RG3) and GV80 (JX1) vehicles may experience difficulty with locking/unlocking the doors using the outer door handle touch sensor. This bulletin provides instructions to apply double-sided tape to the touch sensors to improve detection when moisture is present.

10. Apply the double-sided tape (L) to the indicated area on the touch sensor (K).

Conduct a test fit for proper alignment and position before applying the double-sided tape. Do **NOT** lift the double-sided tape to reposition it after it has already been applied.
