SIB 51 15 24

DELIVERY STOP: PASSENGER SUN VISOR

This Service Information Bulletin (Revision 2) replaces SI B51 15 24 **dated July 2024**.

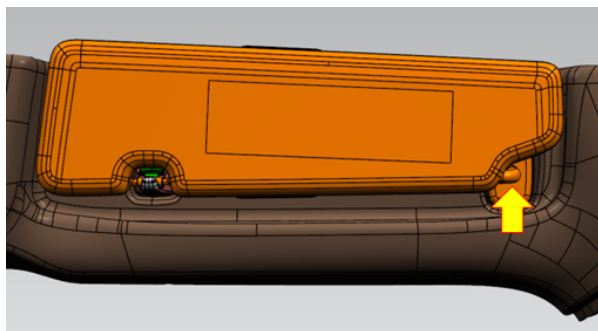
During supplier production, the passenger sun visor shaft may not have been fully pressed into the socket (arrow).

Check and if necessary, replace the passenger side sun visor.

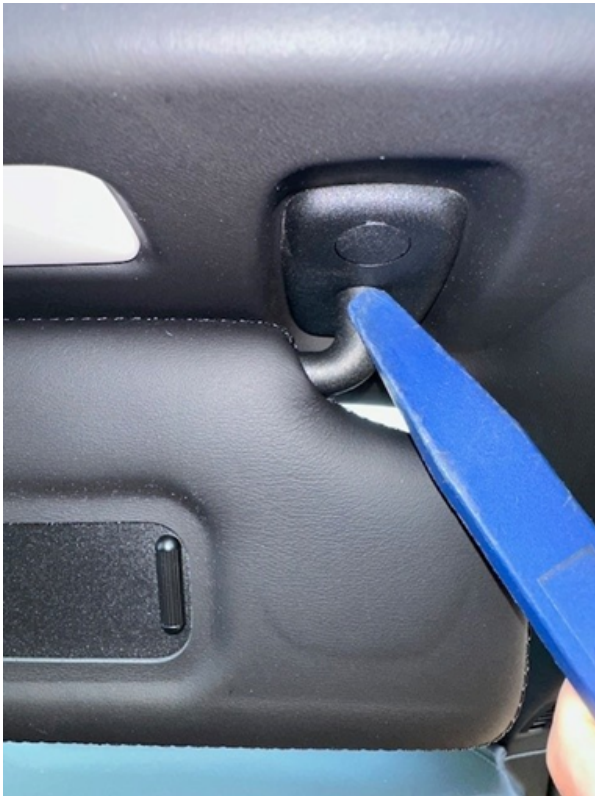
1. Unfold the passenger sun visor and check whether the shaft is fully seated.

Note: Photo indicates an intact sun visor.

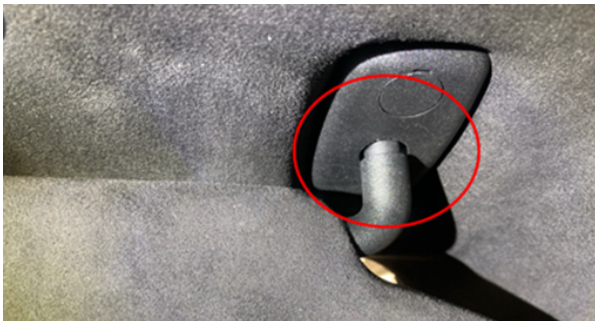
Note: Photo to the left indicates a faulty sun visor.

Note: If the sun visor is in the condition shown with part of the narrower shaft visible, the sun visor will need to be replaced following the repair instructions listed in ISTA/AIR 51 16 080.

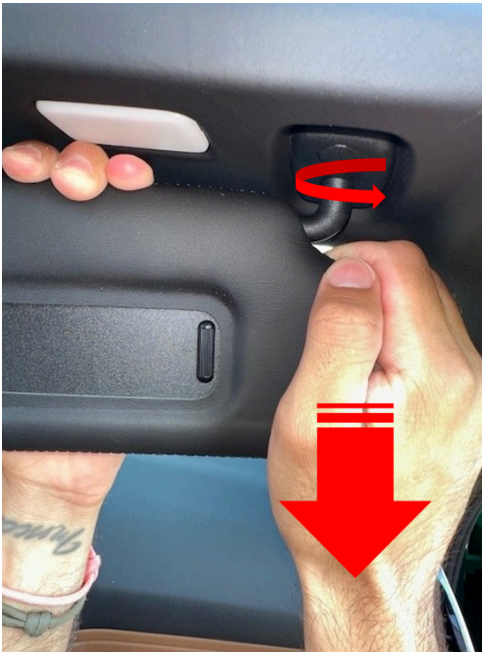
Note: If the sun visor slips out of the socket, it must be replaced following repair instructions listed in ISTA/AIR 51 16 080.

4. Pull the sun visor down with force and combine this with a swivel motion to the right and left.
