Service Bulletin

Bulletin No.: 24-NA-198

Subject: Exhaust Fumes in Cabin and/or Loud Exhaust Noise

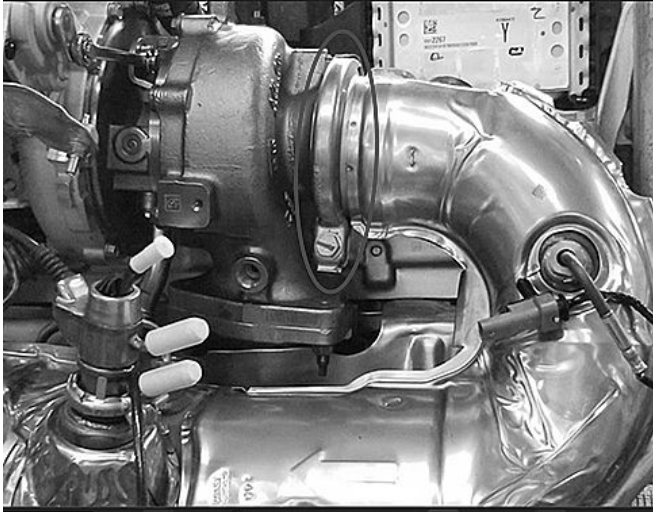
6736478

Involved Region or Country	North America
Condition	Some customers may comment on exhaust fume gas smell inside the cabin and/or a loud exhaust noise.
Cause	This condition may be caused by A misalignment between the Nitrogen Oxides Catalytic Converter and Turbocharge.
Correction	Realign and re-torque the exhaust clamp.

Inspect the connection between the Nitrogen Oxides Catalytic Converter and Turbocharge for exhaust leaks, Align the flange if necessary and torque the clamp to 12 N.m (106 lb in).
