TECHNICAL SERVICE BULLETIN

2.7/3.0L EcoBoost - Engine Oil Leak From The Crankshaft Rear Seal With Retaining Plate

24-2331
23 October
2024

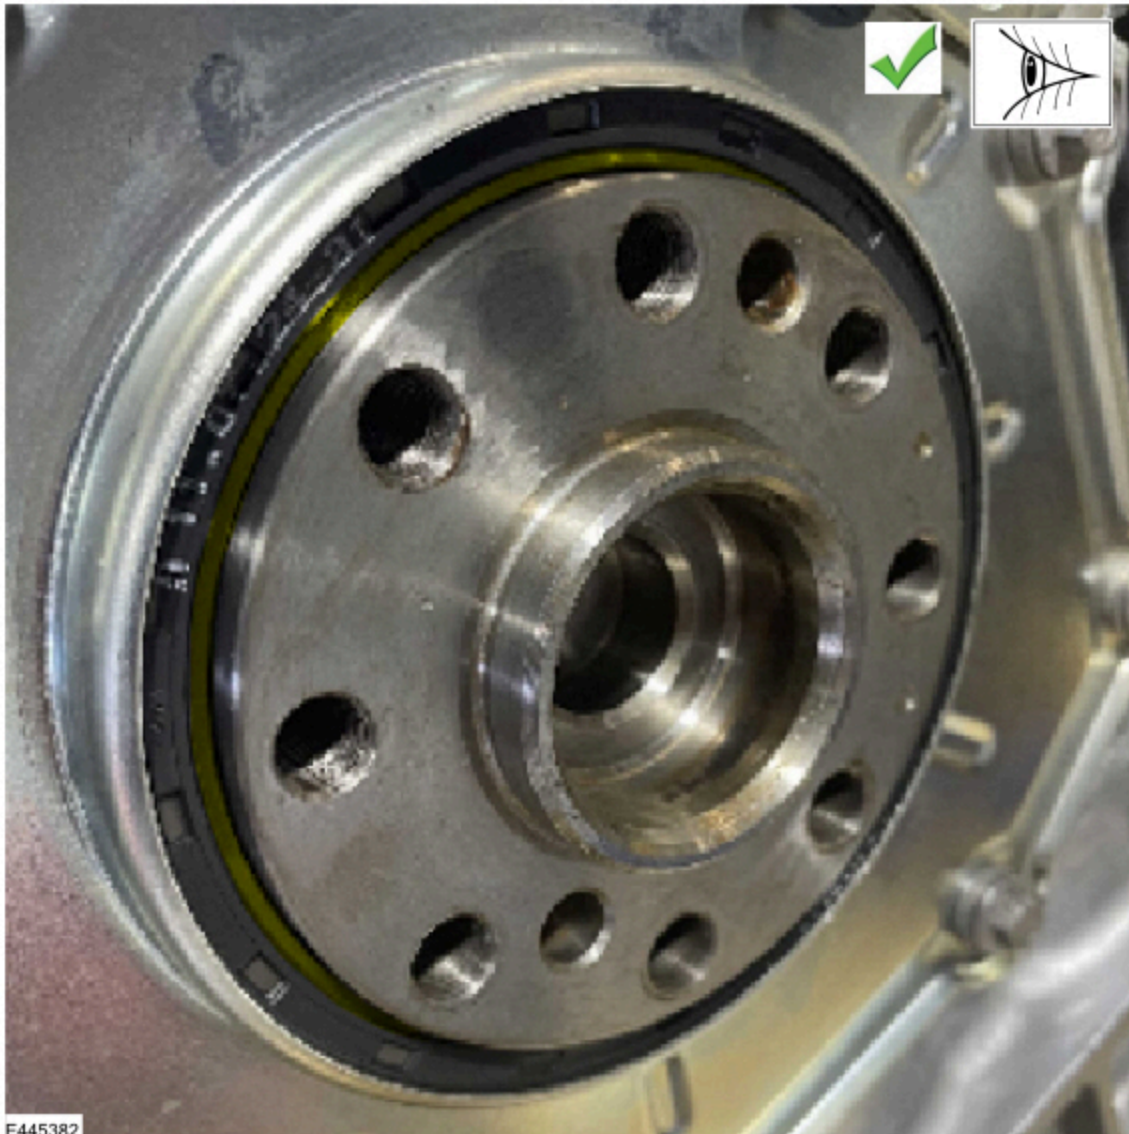
- Lubricate the essential special service tool (ESST) outer surface, rear main seal inner surface, and the crankshaft sealing surface with new engine oil.
- Once the crankshaft rear seal and retaining plate assembly is in place and during the removal of the ESST, closely inspect for seal roll. If a seal is rolled it will create an oil leak. Refer to Figure 1 for an example of a correctly installed seal, Figure 2 for an example of an incorrectly installed seal that has a partial roll, and Figure 3 for an example of a incorrectly installed seal with a fully rolled seal around the entire sealing surface.
- Rear crankshaft seal with retainer plates are one-time-use parts. If the rear crankshaft seal becomes rolled during installation, the rear crankshaft seal with retaining plate assembly must be discarded.
