STAR ONLINE PUBLICATION

Case Number: S2407000002

Symptom/Vehicle Issue: Customer States Vehicle Is Overheating.

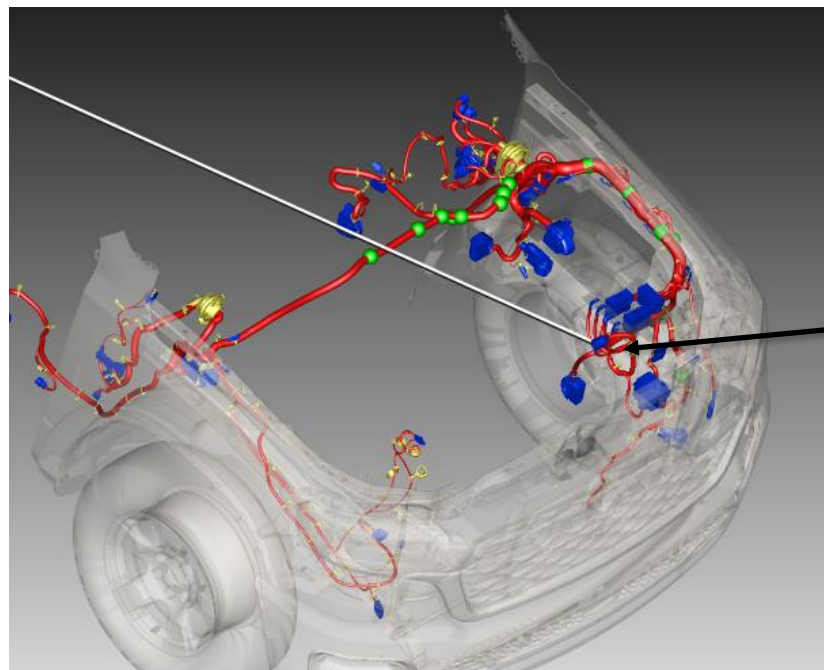
With further investigation P0480 Cooling Fan Control Circuit 1 was showing stored in wiTECH. When observing the radiator fan circuits, it was found that the main fan harness was not zip tied in proper position. Multiple wires were found pinched causing the radiator fan not to turn on.

Location of pinched wires
