Service Bulletin

Bulletin No.: 23-NA-072

Subject: Shudders or Shakes at Low Speeds

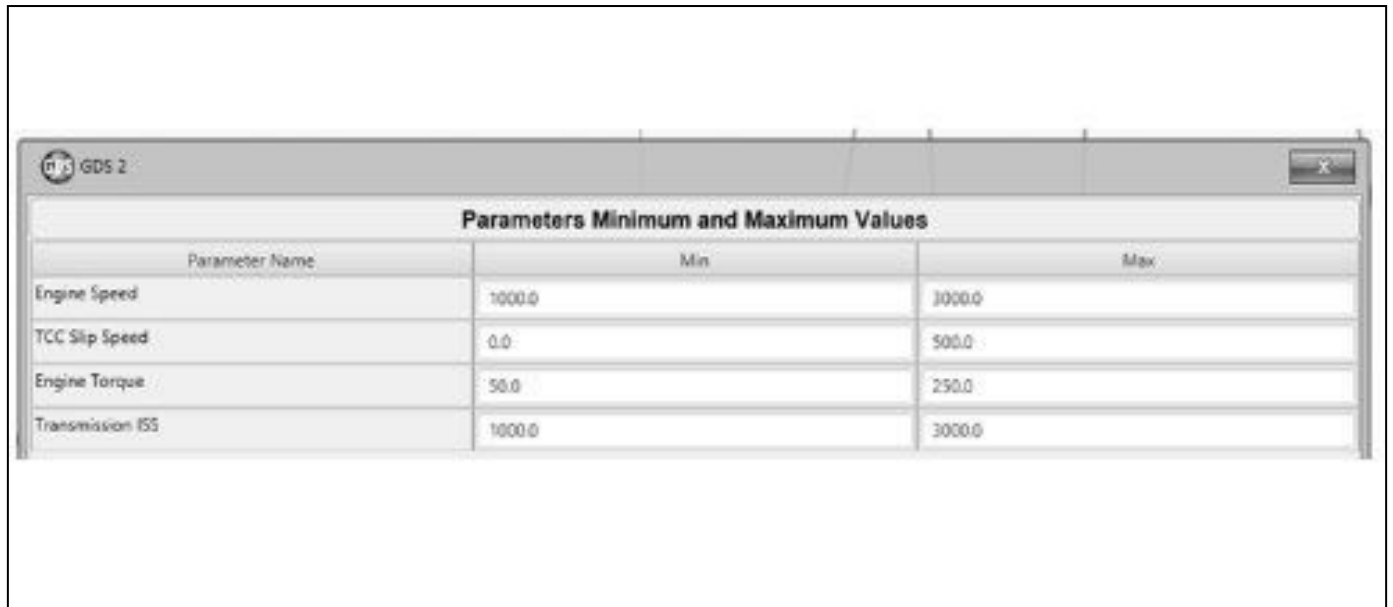
6357390

Record GDS2 Session Log and look for ISS oscillation when driveline disturbance occurs.

Condition present when TCC Slip less than 150 rpm maximum.

1. Engine Speed
2. TCC Slip Speed
3. Engine Torque
4. ISS (Turbine Speed) will show oscillation

TCC Shudder	ISS (Peak-Peak)	Action	Comment
Normal	<50 rpm	Do Nothing	Not a Torque Converter/ATF Issue
Degraded	>50 rpm <200 rpm	Proceed with ATF Drain and Refill	ATF Degradation has occurred. Check Fluid Condition (Instructions below "Fluid Condition Check")
Damage	>200 rpm	Replace Torque Converter	Hardware damage has likely occurred.

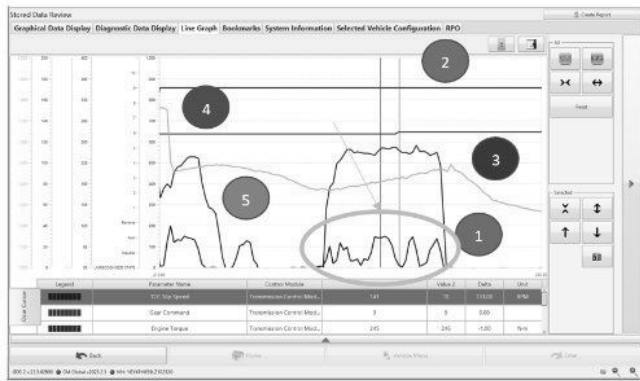
6357391

Poor TCC Control: (Typically seen in higher gear 8th-9th) Steady-State Torque (50-70kph)

1. **TCC Slip**
2. **Gear**
3. **Engine Torque**
4. **ATF Temp**
5. **ISS**

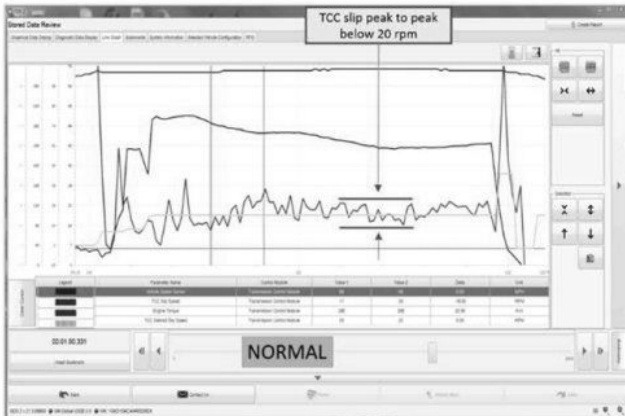
Figure 2 Parameter Normal Test Result

TCC SLIP CONTROL TEST RESULT	TCC RPM Slip Peak to Peak, at Steady Throttle	ACTION
Figure 2 Normal	Below 20 RPM	Do nothing
Figure 3 Degraded	Near 60 RPM - repeating	ATF Degradation has occurred. Check Fluid Condition (Instructions below "Fluid Condition Check")
Figure 4 Damaged	Near 100 RPM-erratic	Hardware damage has likely occurred. Replace Torque Converter

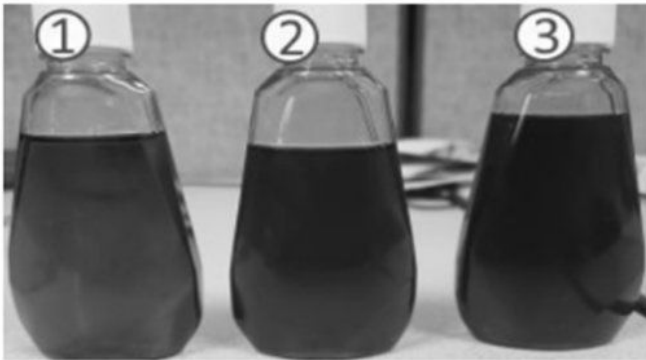
6325134

- The fluid should be red or brown.
- The fluid should be transparent so that objects or writing can be seen through it. Sample #1 is an example of acceptable fluid. Sample #2 is an example of very dark fluid. Sample #3 is an example of black fluid. Samples 1, 2, or 3 would be acceptable to perform the fluid drain and fill if sample does not also have one of the following three conditions.

- In addition to checking the fluid color and transparency, the fluid should be checked for an odor of burnt fluid. If the fluid is very dark (Sample #2), black (Sample #3), and has a burnt odor it would indicate clutch damage has occurred internally in the transmission and it would need to be removed from the vehicle and investigated.

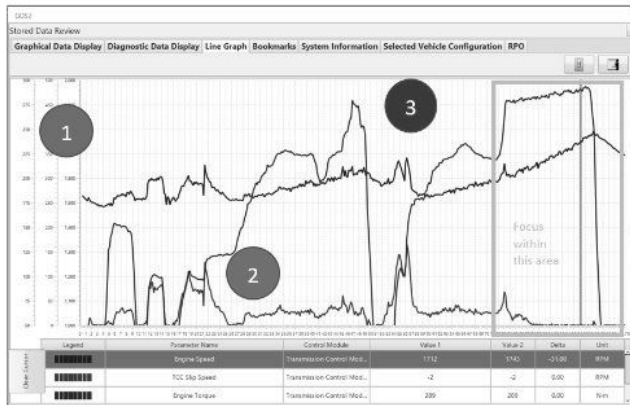
6357392

High Torque Locked Condition — If complaint exists at engine torques >287 Nm, where the measured TCC Slip is ~0 rpm, then this is operating as designed. In order to protect the clutch, we must lock it up at these higher engine torques. Commanding TCC Locked should provide same performance as this condition.

1. **Engine Speed**
2. **TCC Slip**
3. **Engine Torque**
