Service Bulletin

Bulletin No.: 24-NA-032

Subject: Poor Fitting Charge Port Door and/or Charge Port Door Sticks Out at Bottom

Brand:	Model:	Model Year:		Vehicle Build Date:		Engine:	Transmission:
		from	to	from	to		
Chevrolet	Blazer EV	2024	2025	SOP	April 9, 2025	All	All

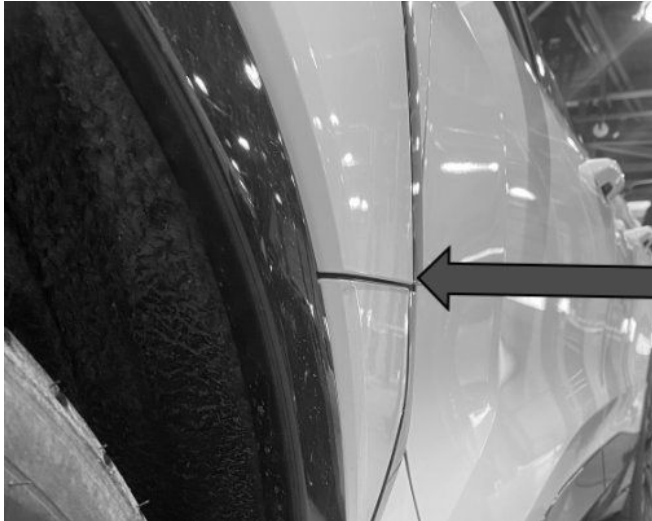
<p style="text-align: right; font-size: small;">6550658</p> <p>Some customers may comment on the charge port door not closing all the way and/or the charge port door sticks out at the bottom.</p>
Cause	The cause of the condition may be due to excessive material on the charge port door.
Correction	Refer to the procedure below to remove some of the material so that the door may close fully as intended.
