Service Bulletin

Bulletin No.: 24-NA-128

Subject: Powertrain Control Module K45 Software Update for SDAC (Serial Data Authentication Configuration) Failures

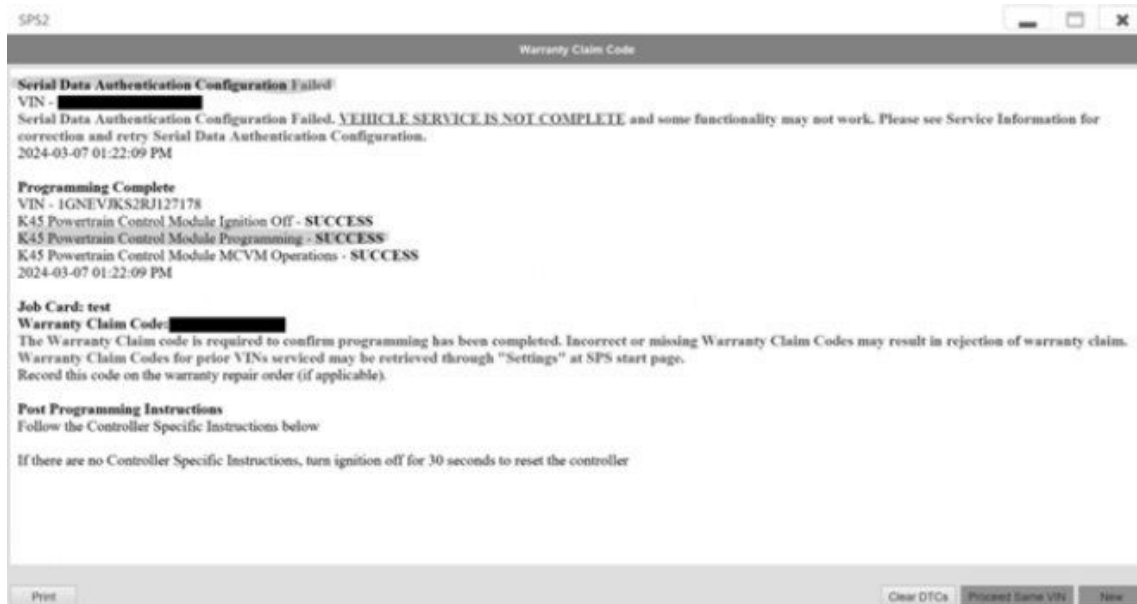
6740333

The following example shows a successful K45 PCM programming event, which is followed by a failed SDAC event. In this example, the K45 PCM is not the cause of the SDAC failure (as outlined in this bulletin) since it was successfully programmed with the latest software.

If the K45 PCM programming is unsuccessful -or- SDAC is failing after successful K45 PCM programming, please disregard this bulletin and follow service information and procedures to determine failure.
