Service Bulletin

Bulletin No.: 24-NA-163

Subject: 2nd Row Bench High Effort for Easy Entry When Tipping the Seat Back Forward

Brand:	Model:	Model Year:		Vehicle Build Date:		Engine:	Transmission :
		from	to	from	to		
Chevrolet	Traverse	2024	2024	-	-	LK0	All

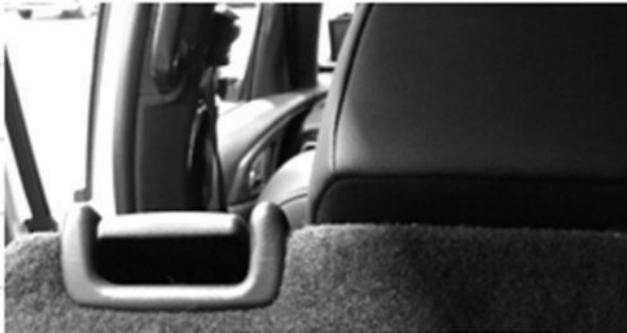
<p style="text-align: right; margin-right: 20px;">6720014</p> <p>Some customers may notice excessive force is needed when using the seat back fold option for easy entry into the third row. This is only for vehicles equipped with ABC (2nd row bench) seats.</p> <p>This is the handle located on the top of the seat back next to the headrest on the driver side.</p>
Cause	The cause of the condition may be the cable splitter has internal friction binding that can cause high effort.
Correction	Swapping the cable fitting attachment location at the cable splitter.
