Service Bulletin

Bulletin No.: 24-NA-204

Subject: Ignition Button LED Inoperative and/or Lights in the Dash Flicker or Not Illuminate, Possible B1837 - LED Backlight Dimming Control Set and Blown IP Fuse F9DA

Brand:	Model:	Model Year:		VIN:		Engine:	Transmission:
		from	to	from	to		
Cadillac	XT4	2024	2024	-	-	All	All

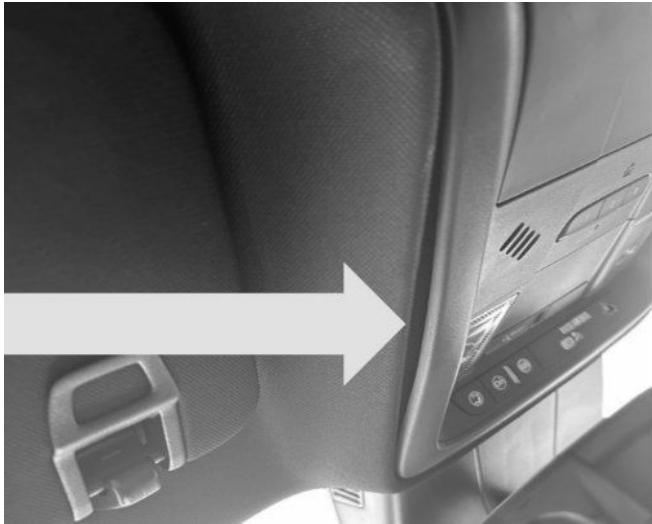
<p style="text-align: right;">6737910</p> <p>The cause of the condition may be improper routing of the overhead console harness being clipped into the roof sometimes resulting in a bulge in the overhead console like illustrated above.</p>
Correction	Refer to the procedure outlined below.

1. Remove the overhead console. Refer to *Roof Console Replacement* in Si.

2. Repair the damage to the wire insulation and replace fuse F9DA if needed.
3. Reinstall overhead console. Refer to *Roof Console Replacement* in Si.
4. Verify condition is corrected.
